Asset Home Inspections Inc.

Home Inspection Report

1 Skyblue Path, Great Town, NY 11701

Date of Inspection: 2/1/2022 Time: 10am

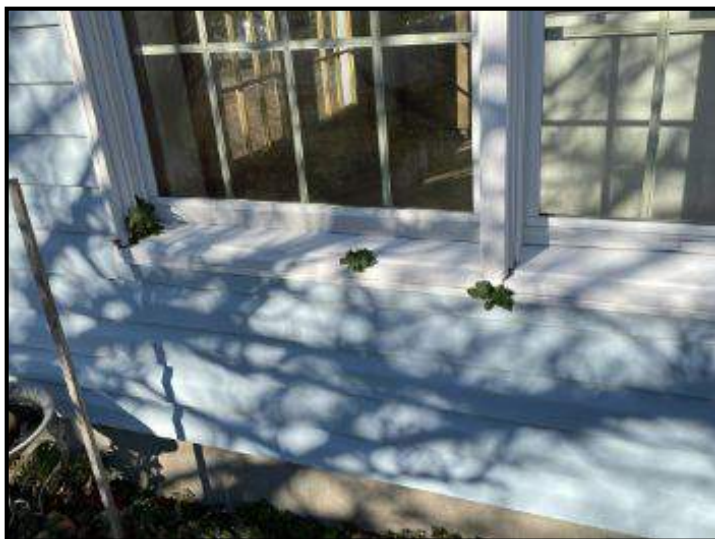
- Minor vegetation growing around front lower window; recommend removal.
- Tall trees in vicinity of home, over-hanging edge of roof; recommend to consult a qualified landscaper to access health and for proper pruning.

Minor vegetation growing around front lower window

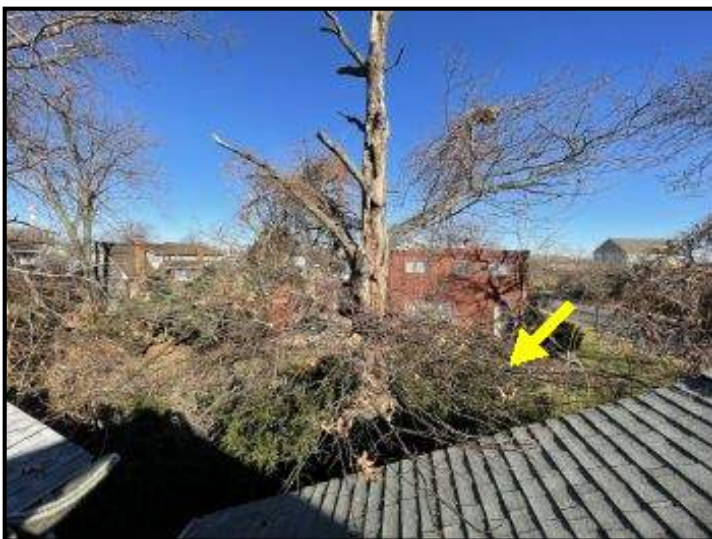
Tall tree and branches over-hanging edge of garage roof

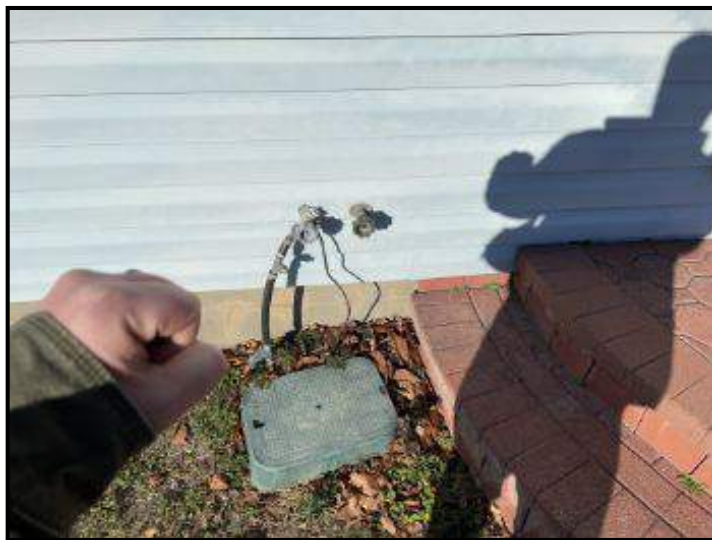
- **No flow at exterior faucets around the home; appear to be off from interior. Recommend to confirm operation, prior to the Closing.**

Front faucet did not operate

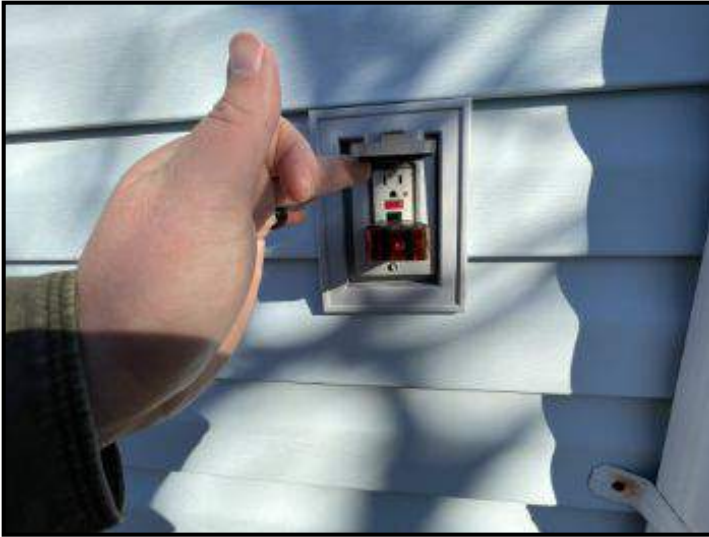
- **Non-energized outlet at side of home; recommend further evaluation by a qualified electrician.**

Grounded GFCI outlet at side of home

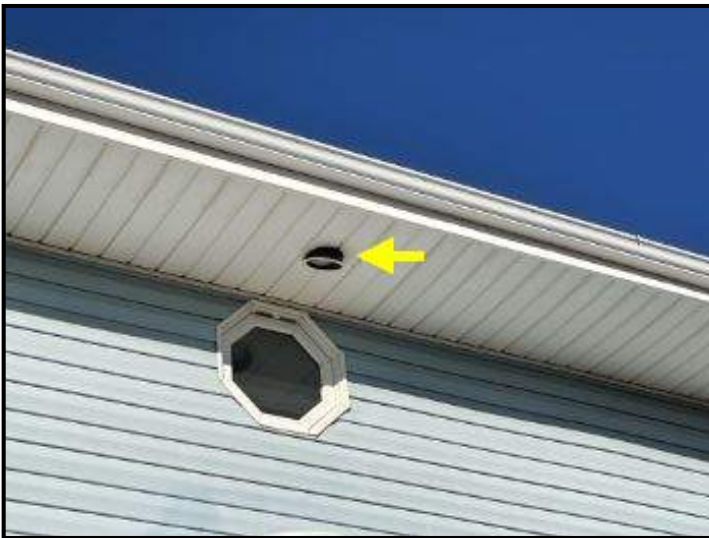
- Exterior lights at front eave not properly secured, recommend repair.
- Exterior lights beneath front eave did not operate; recommend further evaluation; replacing bulbs or repair, as appropriate.

Exterior lights at front eave not properly secured

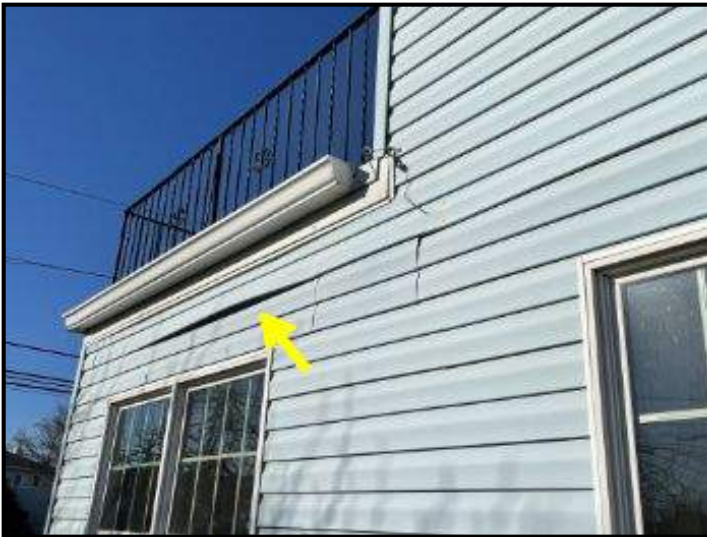
Siding not properly fastened at front of home; appears previously patched

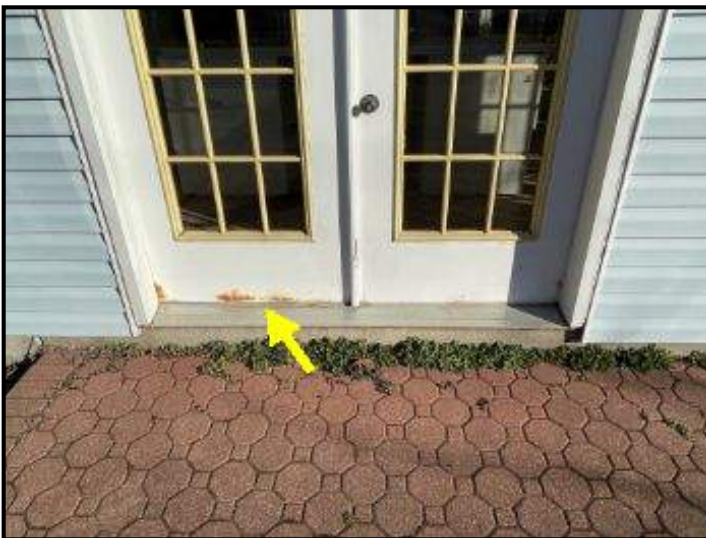
Rust observed at lower portions of exterior doors

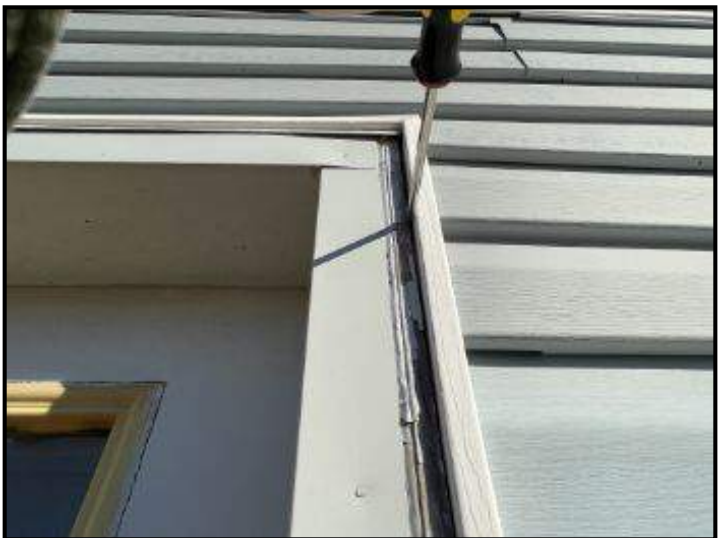
Voids around side doors

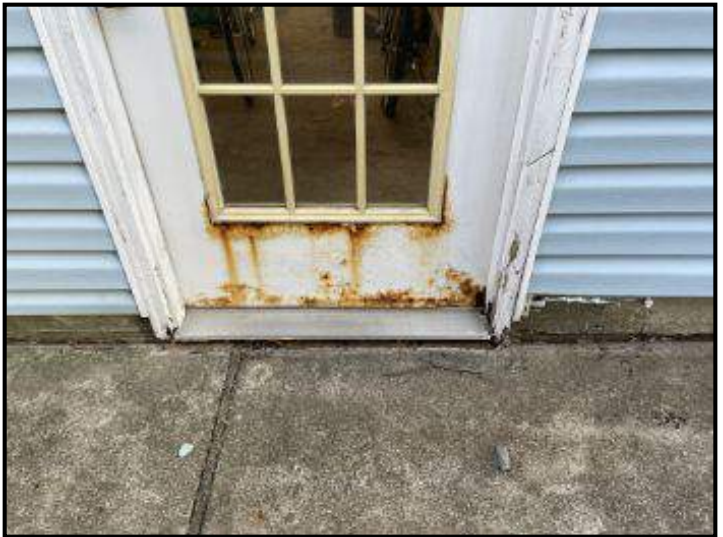
Significant rust at rear garage door

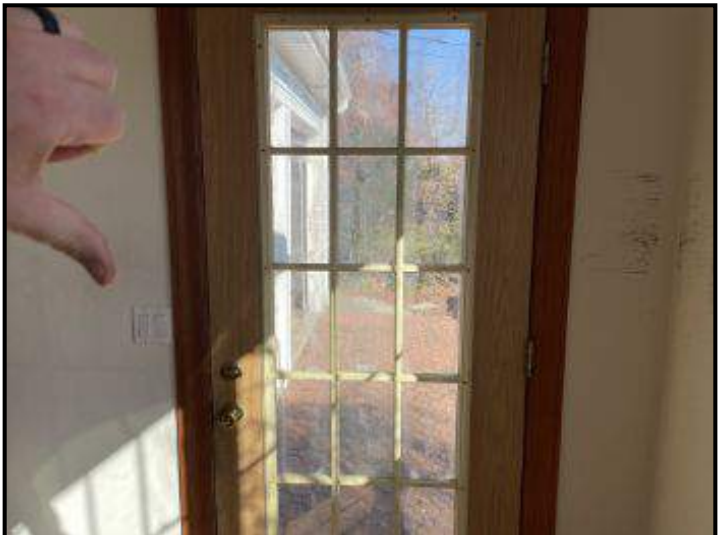
Moisture between panes at front-side door

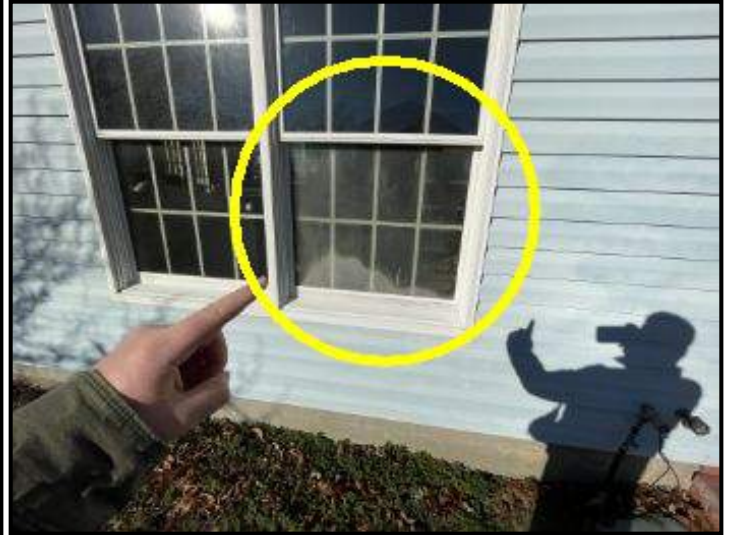
Moisture between panes at front lower window

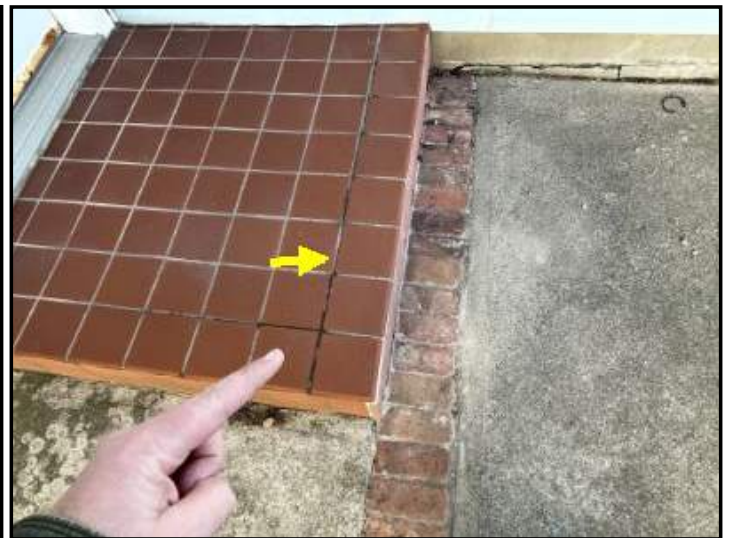
- The front and rear stoop appeared in serviceable condition. Mortar cracks at rear tiled stoop are recommended to be sealed to prevent further damage.

Crack in mortar joint at rear tiled stoop

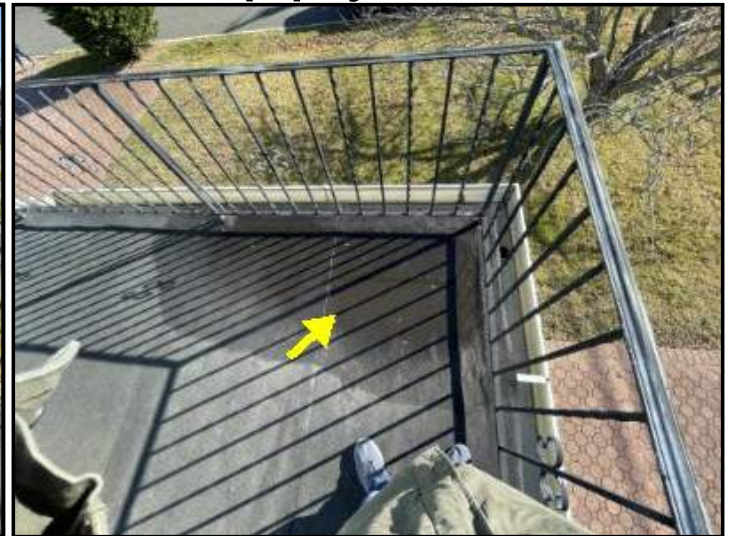
Low area at edge of upper balcony; standing water observed

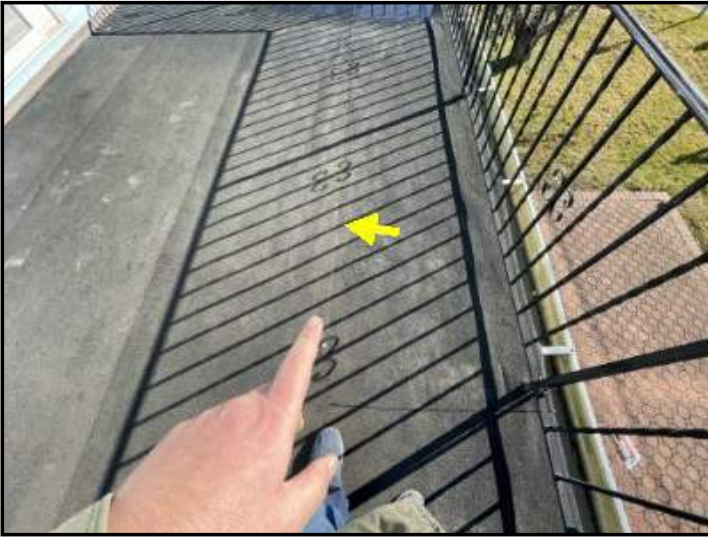
- Some areas of flat roll roofing at upper balcony bubbled/soft; recommend further evaluation by a qualified roofer.
- Non-energized outlet at upper exterior balcony; recommend further evaluation by a qualified electrician.

Some areas of flat roof roofing at upper balcony bubbled/soft

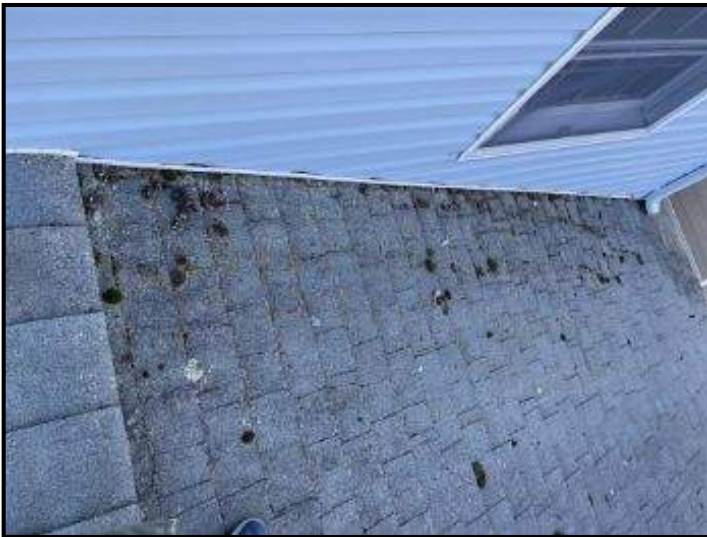
Some moss/algae growth at rear garage roof

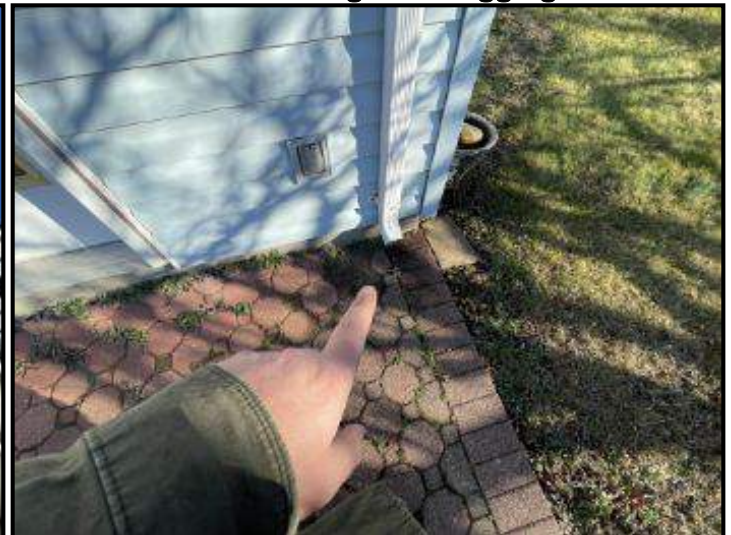
No extensions at gutter downspouts around the home

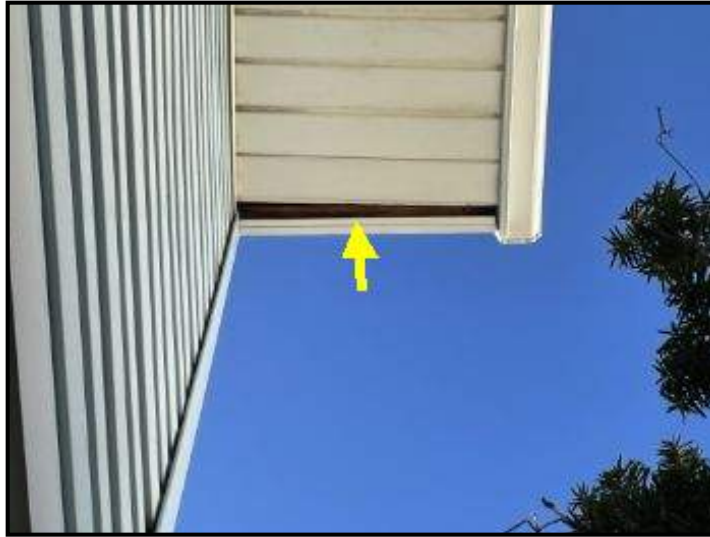
- Missing area of soffit trim at rear eave; recommend installing.

Missing area of soffit trim at rear eave

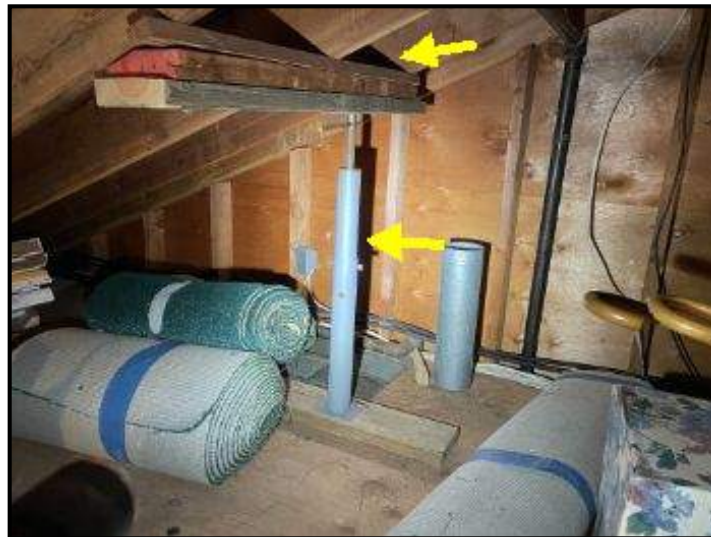
- Adjustable column stabilizing roof rafters above garage; does not appear adequate. Recommend further evaluation by a qualified roofer.

Adjustable column stabilizing roof rafters above garage

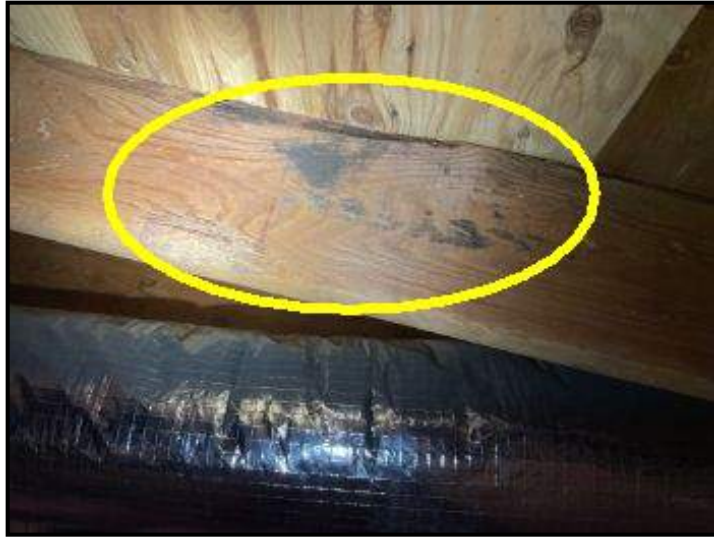
- Mold-like growth observed on some rafters; recommend a qualified mold specialist further evaluate.

Minor areas of possible mold at roof rafters in attic

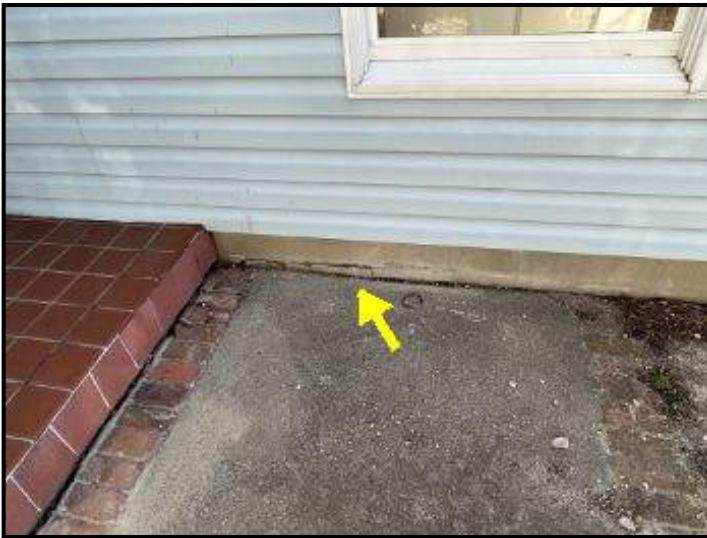
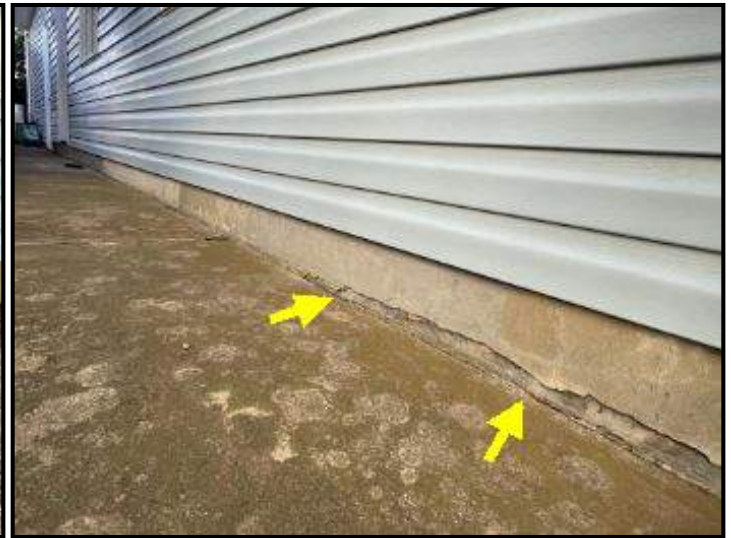
- The foundation walls appeared to be poured concrete with a concrete board parging at exterior.
- Several parging areas at lower portion of foundation walls were cracked; not structurally significant. Recommend repair/re-parging damaged areas.

Cracked concrete parging at several areas around the home

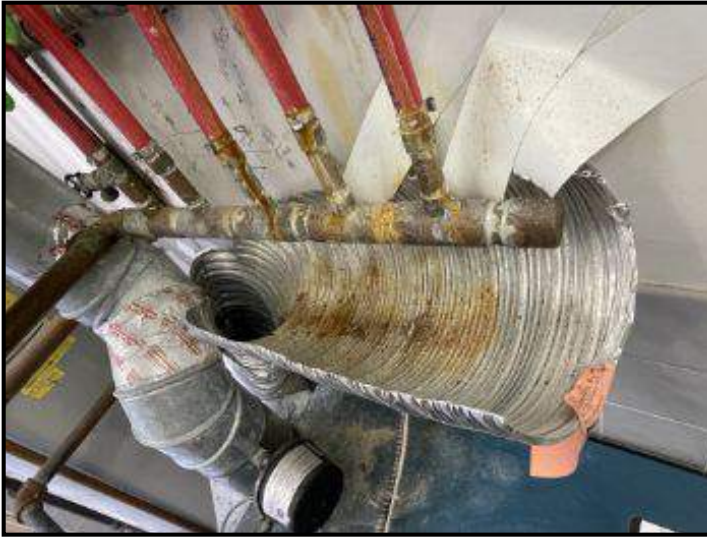
- **Pressure relief valve not properly installed; no down-line present; recommend further evaluation by a qualified plumber.**
- **Evidence of possible leak/condensation at manifold above boiler; brown staining visible from ceiling down Pex water tubing; recommend further evaluation by a qualified plumber.**

Evidence of possible leak/condensation at manifold above boiler

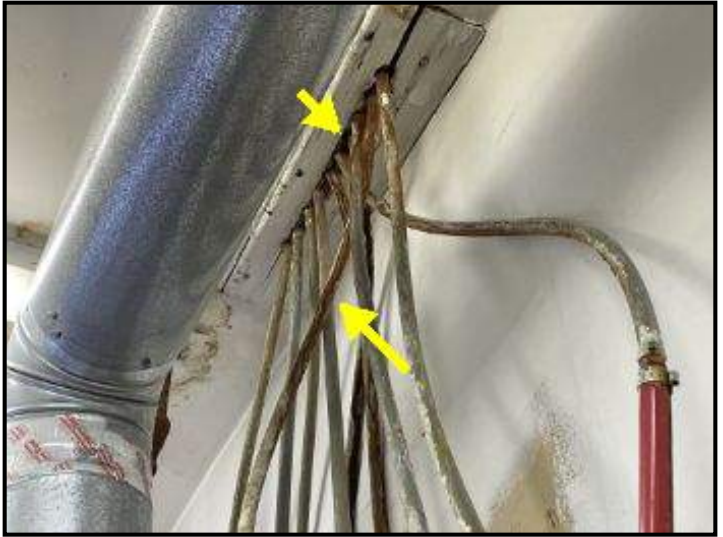
Brown staining at ceiling/down pex water tubing

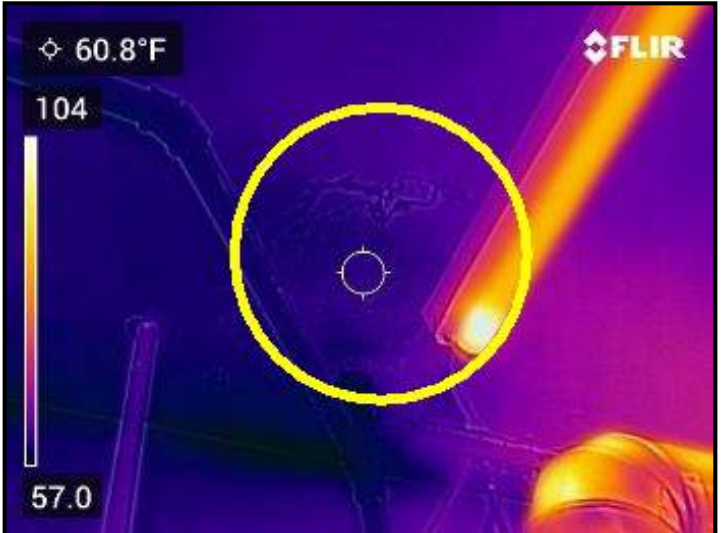
No current moisture observed around water piping above boiler

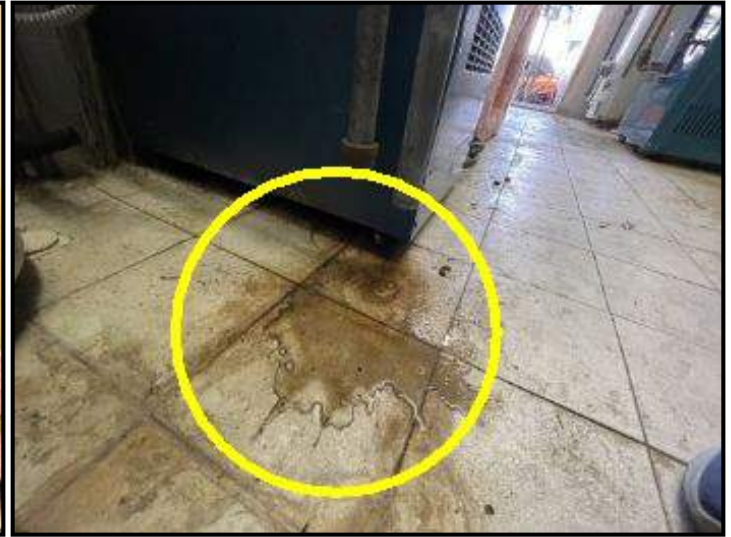
- **Moisture observed beneath lower level boiler pressure relief valve, indicating relief valve is failing or high pressure within the unit; recommend further evaluation by a qualified plumber.**

Moisture observed beneath lower level boiler pressure relief valve

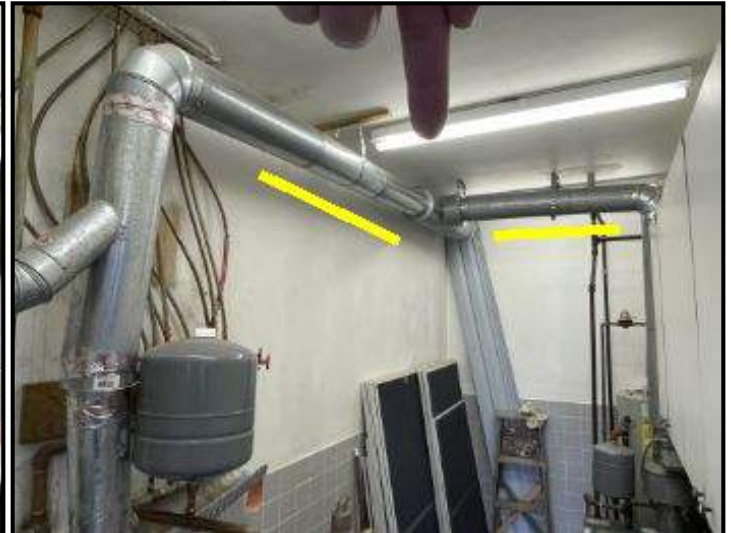
- **Boiler exhaust vents appeared flat, not properly pitched, and significant length to vertical chimney; recommend to consult qualified plumber to deem exhaust venting is appropriate.**

Boiler exhaust vents appeared flat and significant length

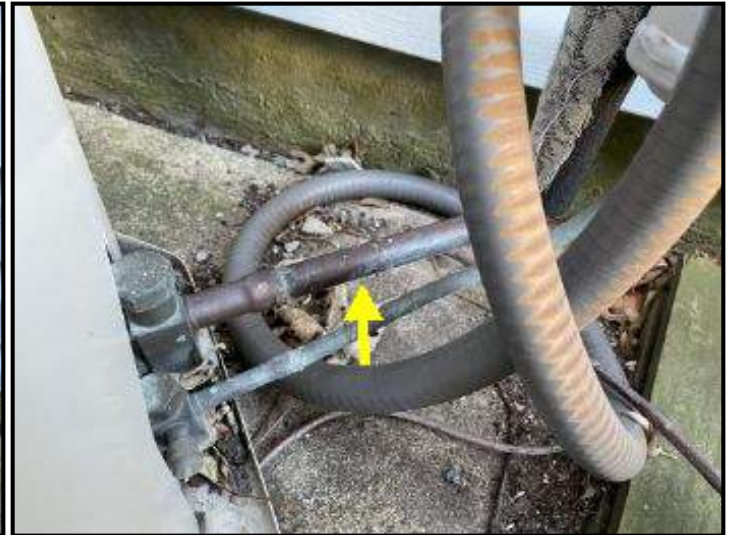
Areas of suction line missing insulation

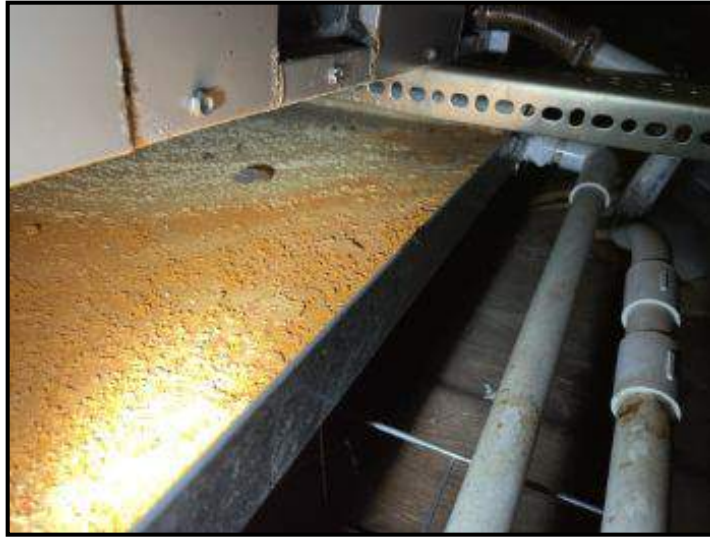
Rust observed at AC evaporator pan; no float shut-off switch encountered

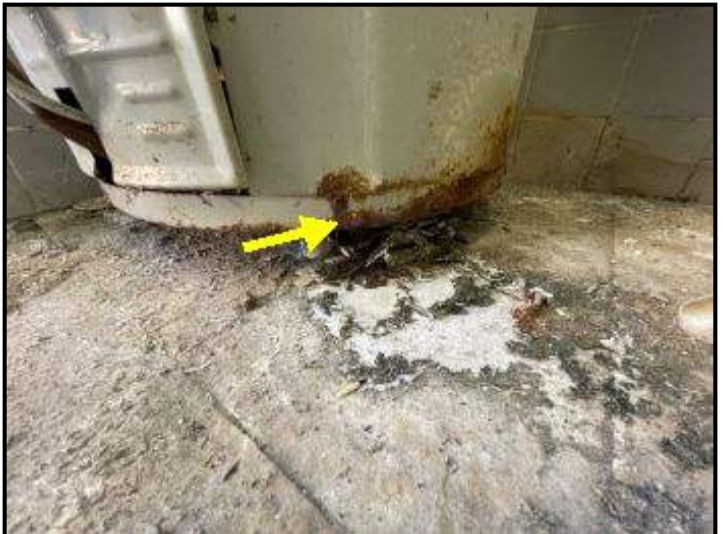
Rust around base of hot water heater

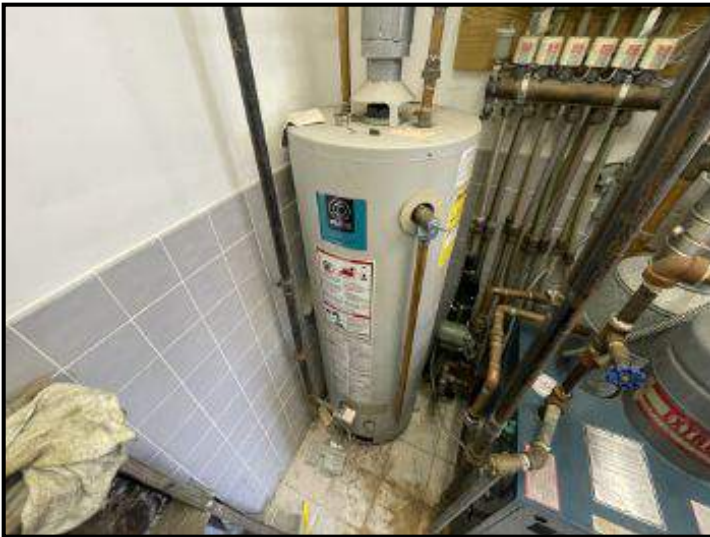
Lower level hot water heater; did not operate

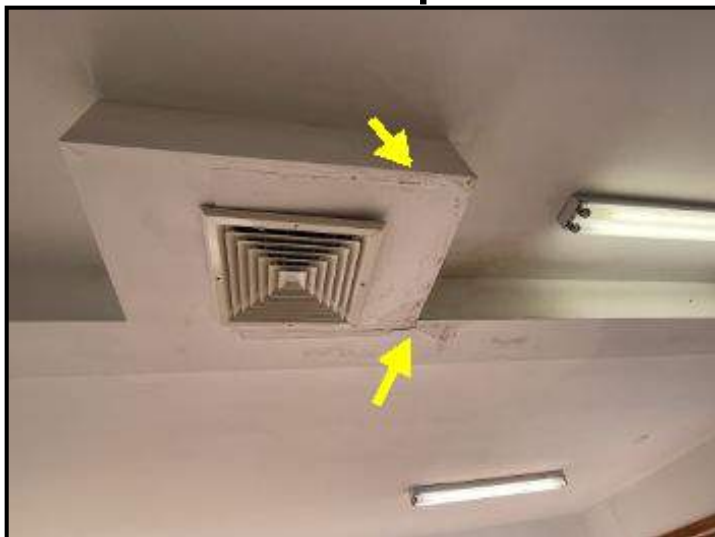
- Recommended replace air filters (at unit or return grills), as warranted.
- Moisture stains observed at air ducts above lower main living/office room; possibly caused from condensation; recommend further evaluation by a qualified HVAC contractor.

Moisture stains observed at air ducts above lower main living/office room

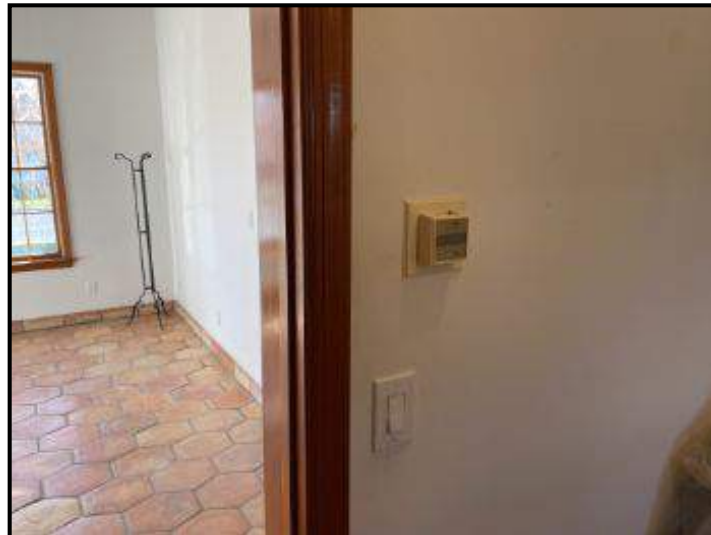
- Thermostat appears aged. Recommended to consider upgrading.

Aged thermostats throughout home

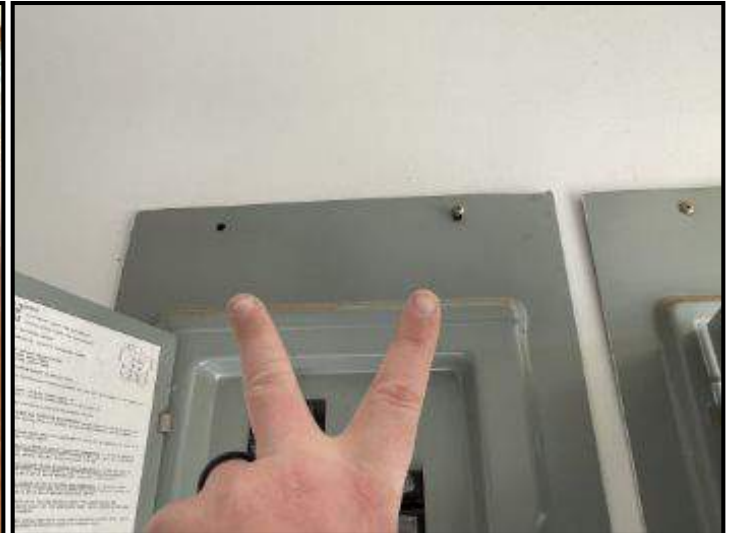
Some missing/loose screws at service panel

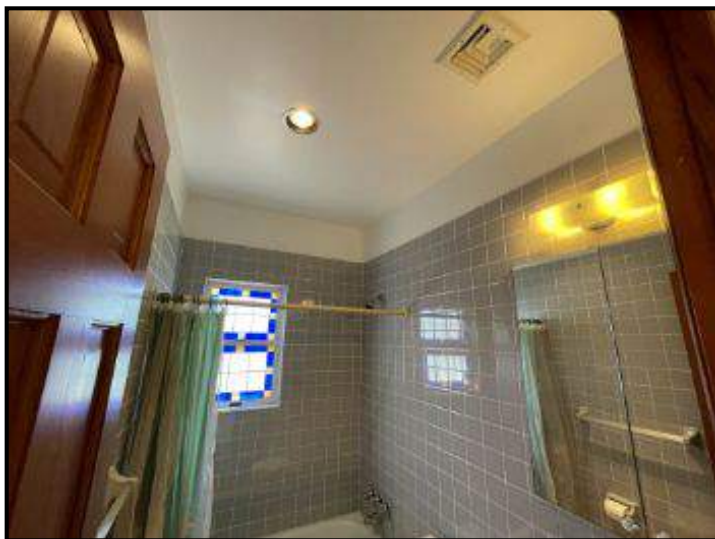
No exhaust fan at lower main bathroom

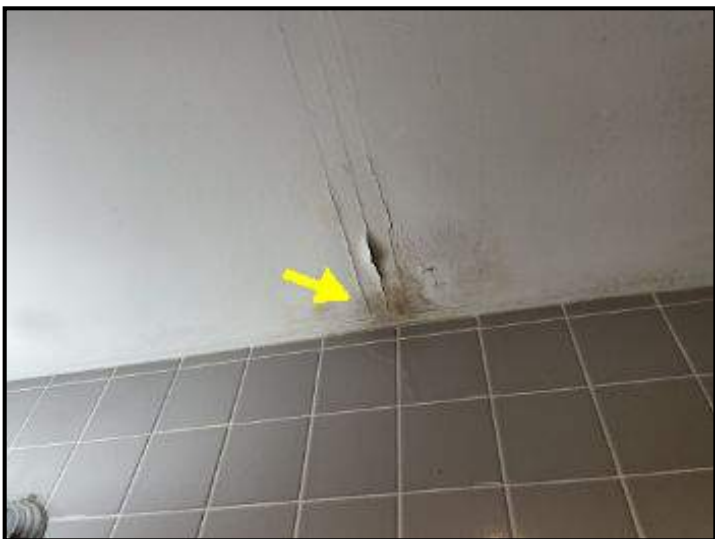
Apparent previous moisture stain at upper main bathroom ceiling; no current moisture observed

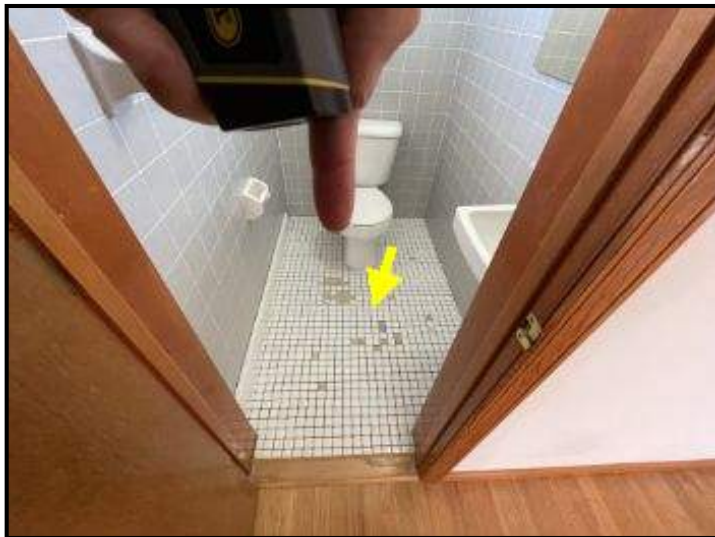
Low area in floor at upper ensuite bathroom

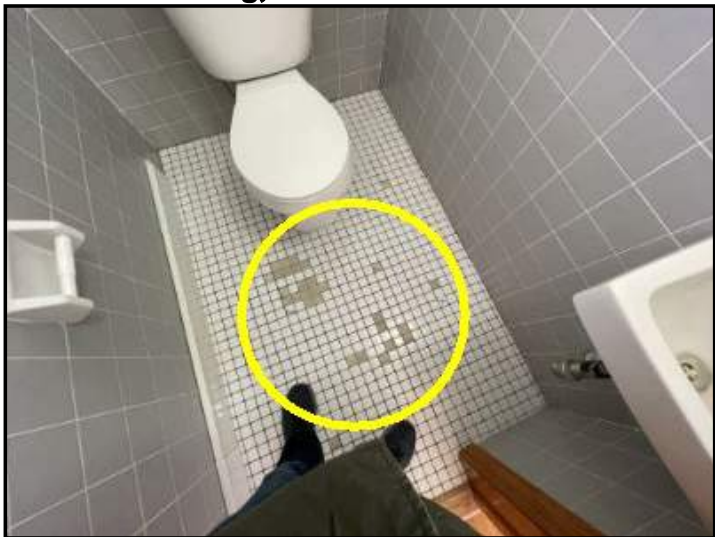
Some missing floor tiles at upper ensuite bathroom

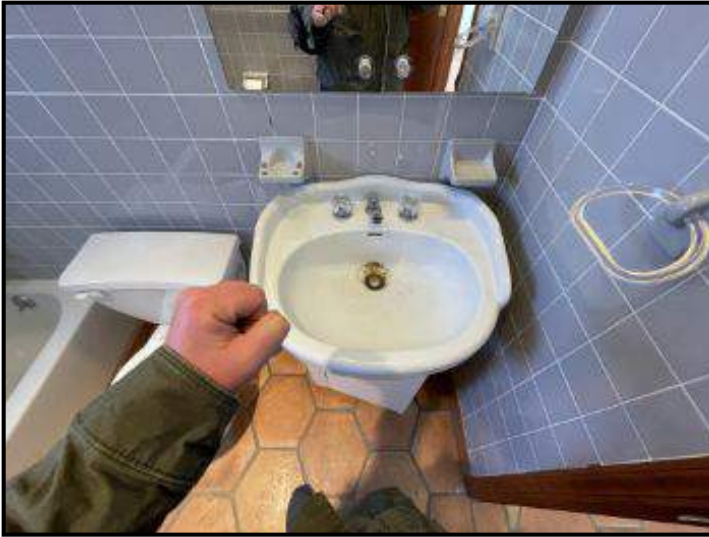
No running water at lower main bathroom sink

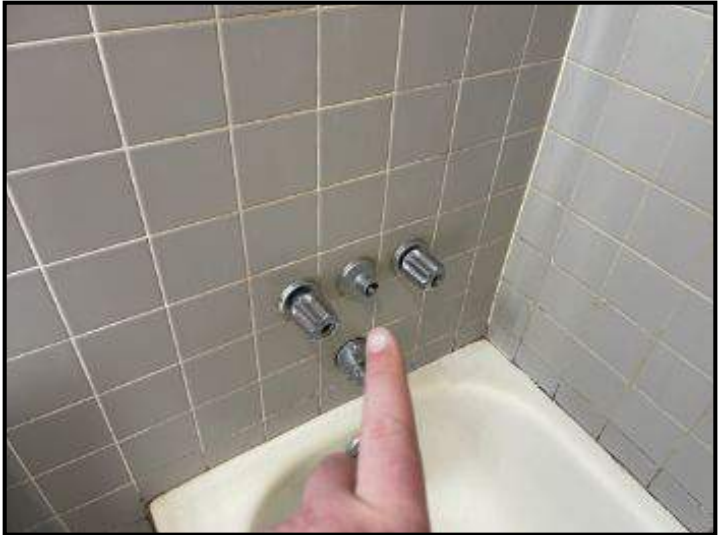
Missing faucet handle at upper main bathroom tub

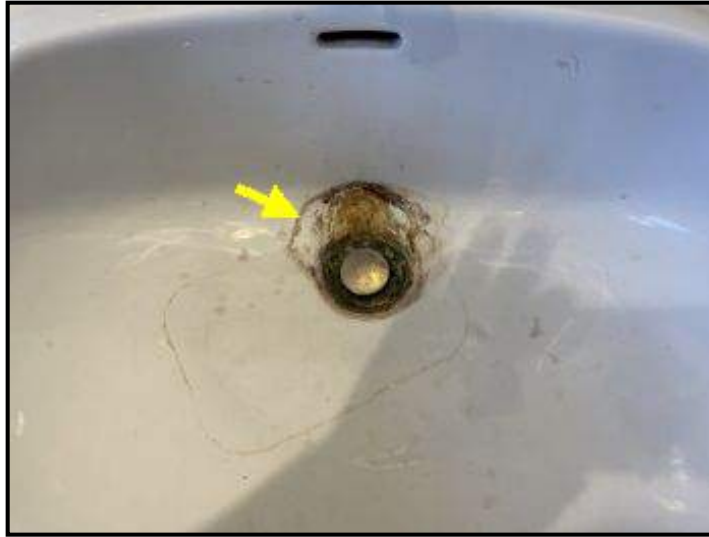
- **Chipped area of lower main bathroom sink; recommend replacement.**

Chipped area of lower main bathroom sink

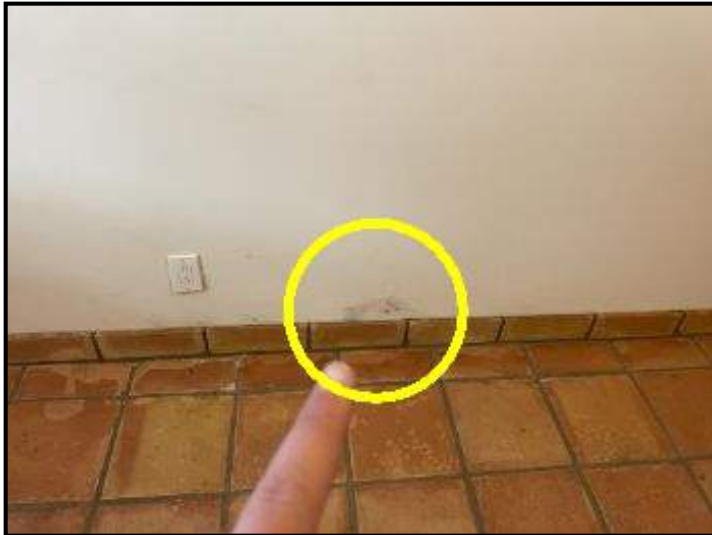
- Possible mold at lower rear office wall and lower living room/office ceiling; recommend further evaluation by a qualified mold specialist. Also, see Overall Home Condition report section.
 - Some staining was observed at areas of tiled flooring at lower level; recommend removal.
 - Several cosmetic cracks/seams at lower and upper living room walls/ceilings; recommend repair.
- Apparent moisture damage at front corner of main living room/office; appears associated to void at exterior fascia trim and leak at gutter-seam. Recommend further evaluation by a qualified contractor. See associated report sections for issues pertaining to moisture damage.

Possible mold at lower rear office wall

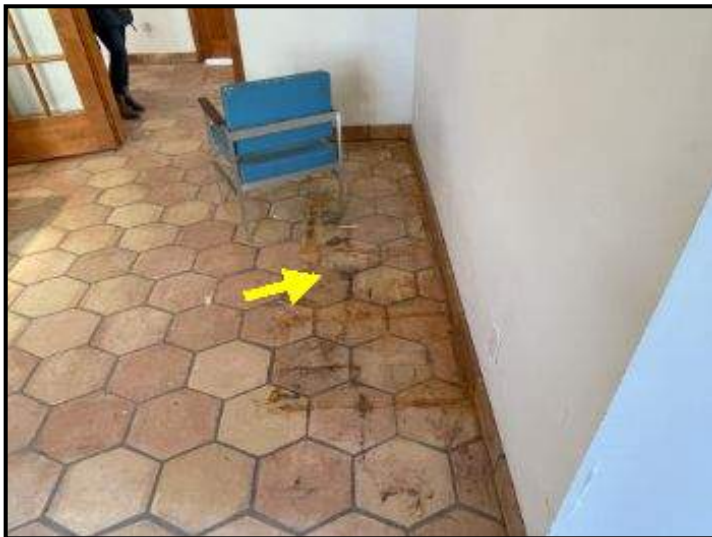
Some staining was observed at areas of tiled flooring at lower level

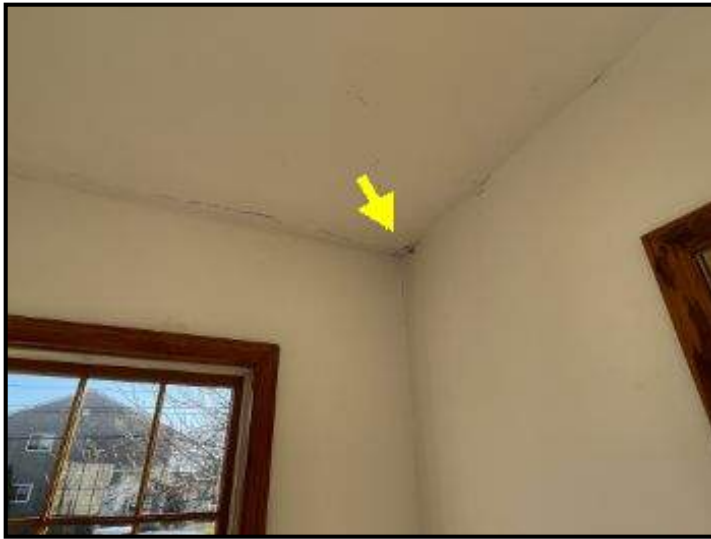
Living, Family & Dining Rooms		
Page 52 Item: 1	Floors, Walls & Ceilings	<ul style="list-style-type: none"> • Apparent moisture damage at front corner of main living room/office; appears associated to void at exterior fascia trim and leak at gutter-seam. Recommend further evaluation by a qualified contractor. See associated report sections for issues pertaining to moisture damage.
Page 53 Item: 2	Windows	<ul style="list-style-type: none"> • Moisture between panes at lower front living room

Apparent moisture damage at corner of main living room/office

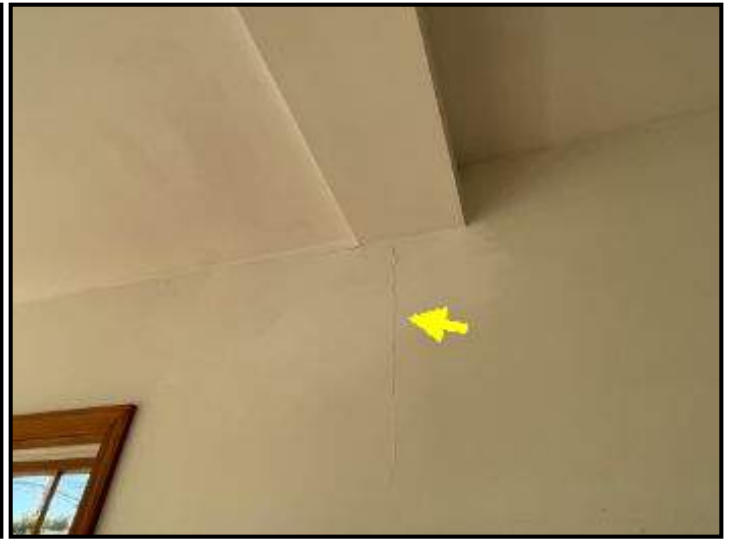
Cosmetic seams at main lower living room/office walls

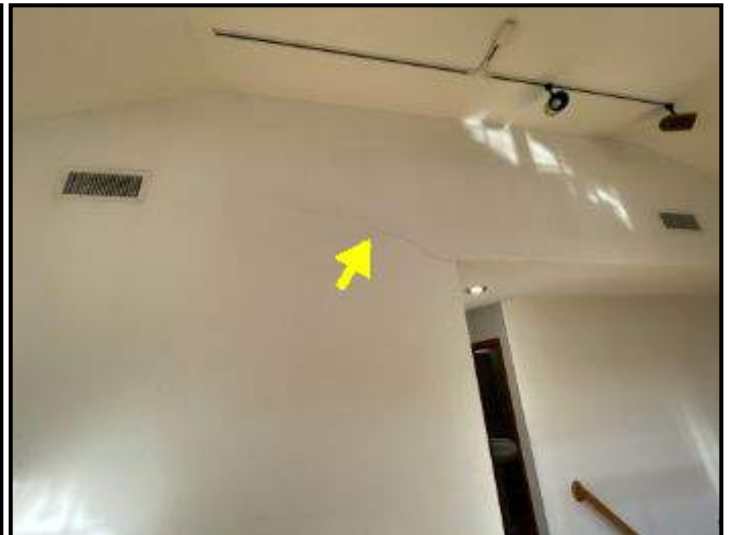
Cosmetic crack/seam at upper living room wall

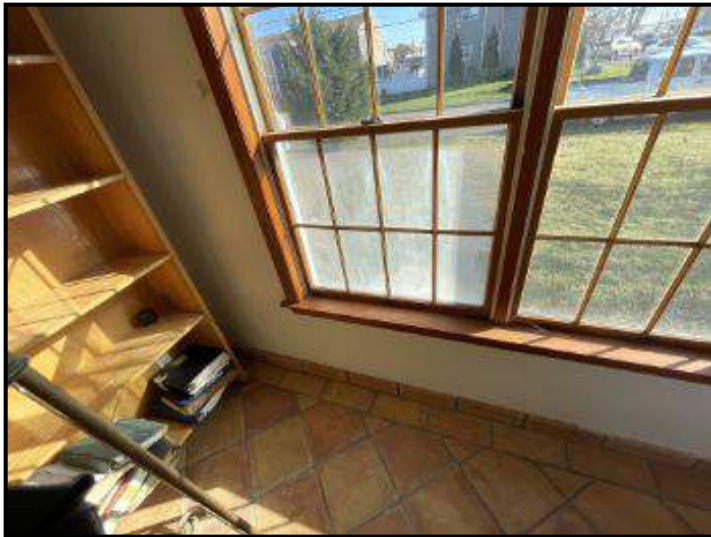
Moisture between panes at lower front living room window

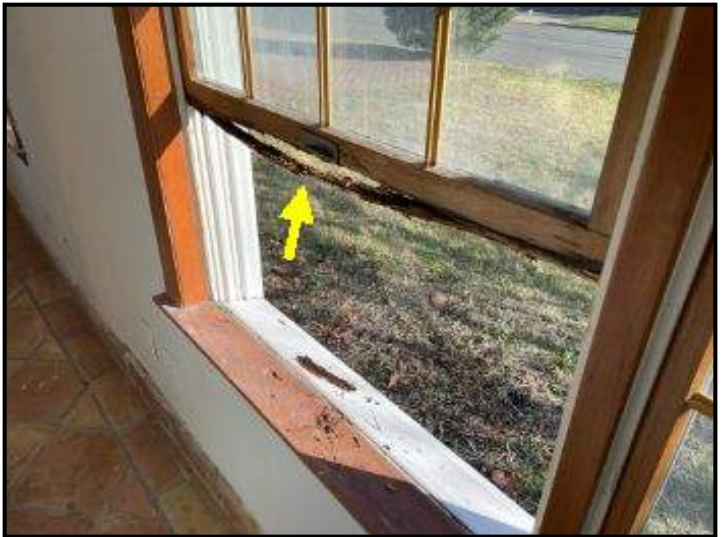
Deteriorated base of lower main living room/office window frame

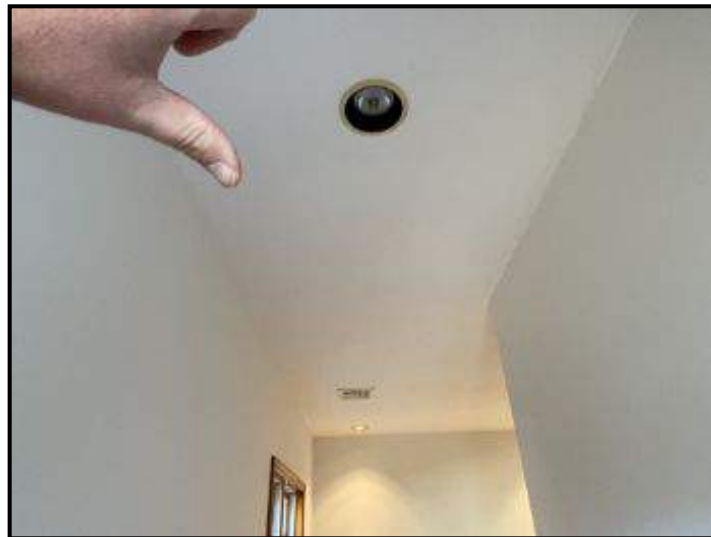
- Some ceiling lights at lower rear room did not operate; recommend repair.

Some ceiling lights at lower rear room did not operate

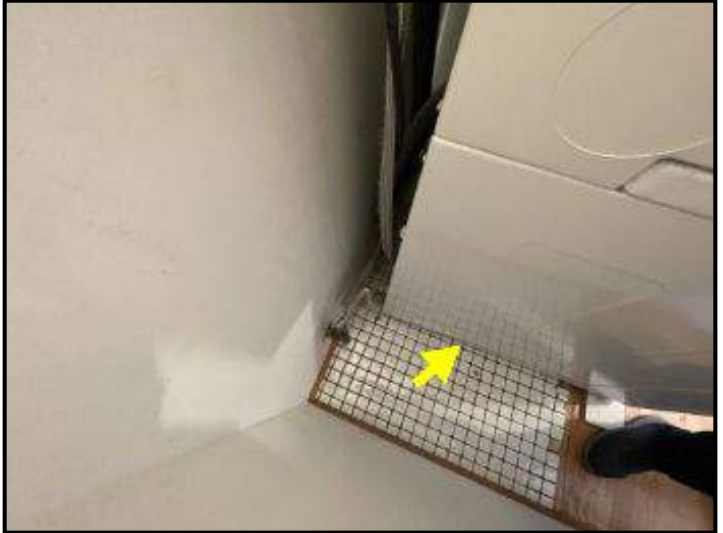
No pan beneath washer/dryer for potential leak

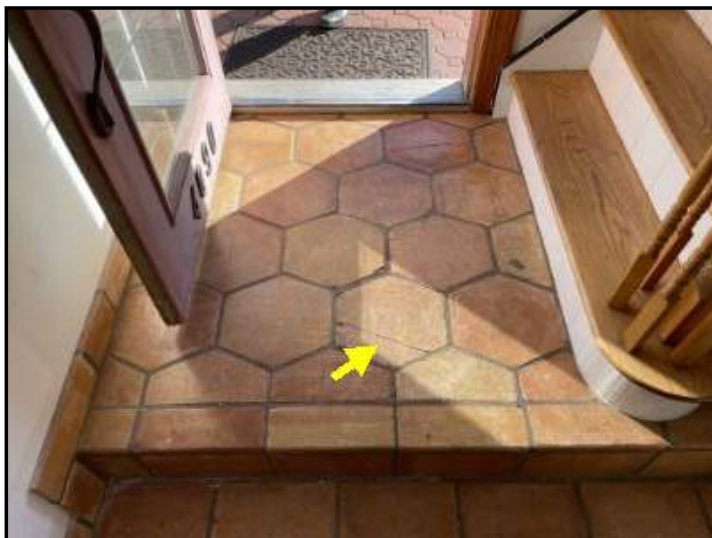
Cracked tiles at front entrance

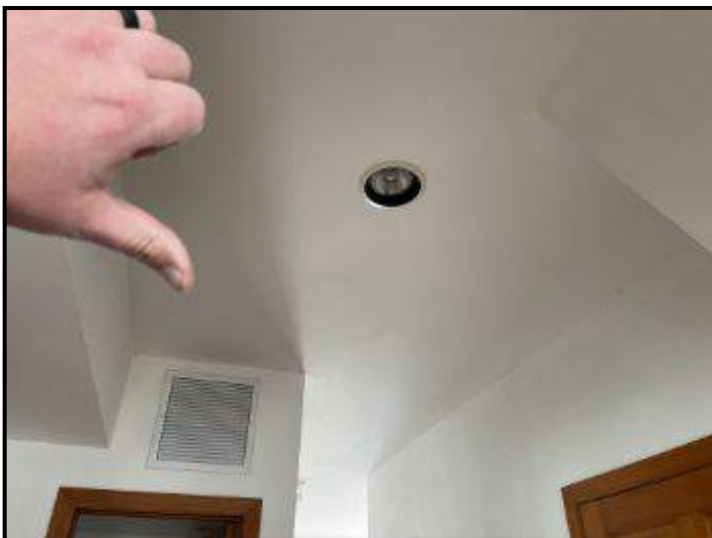
Hallway ceiling light did not operate

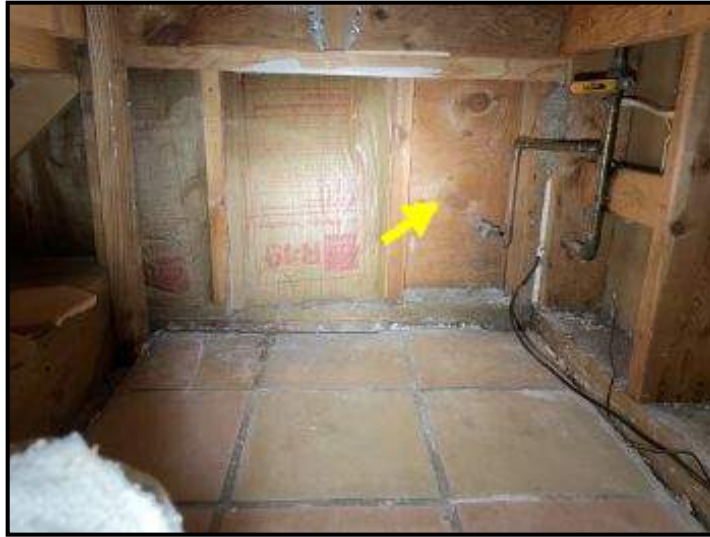
Missing areas of insulation at front exterior wall in closet beneath main staircase

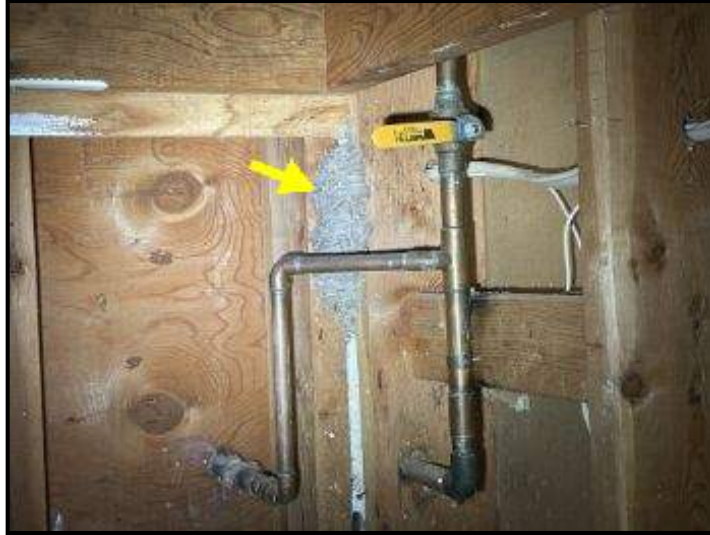
- **Wasp nest between studs at front exterior wall in closet, beneath main staircase. Recommend further evaluation by a qualified exterminator for removal.**

Wasp nest between studs at front exterior wall in closet beneath main staircase
