Asset Home Inspections Inc.

Home Inspection Report

1 Skyblue Path, Great Town, NY 11701

Date of Inspection: 2/1/2022 Time: 10am

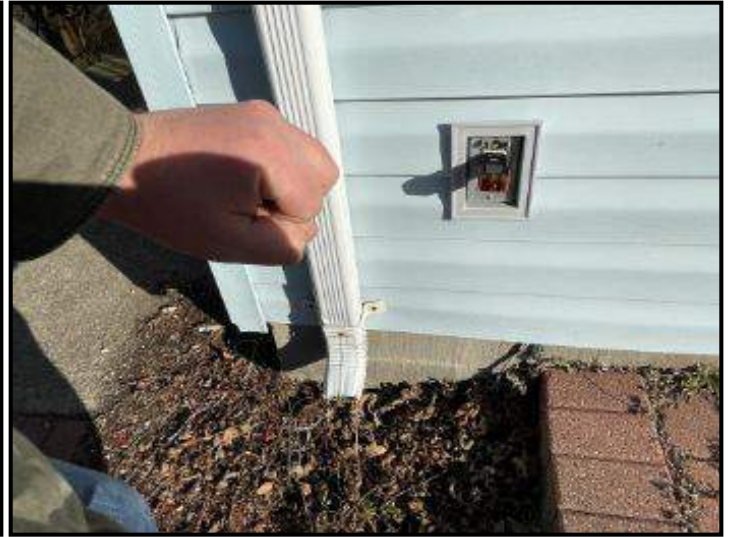
- **Non-energized outlet at side of home; recommend further evaluation by a qualified electrician.**

Non-energized outlet at side of home

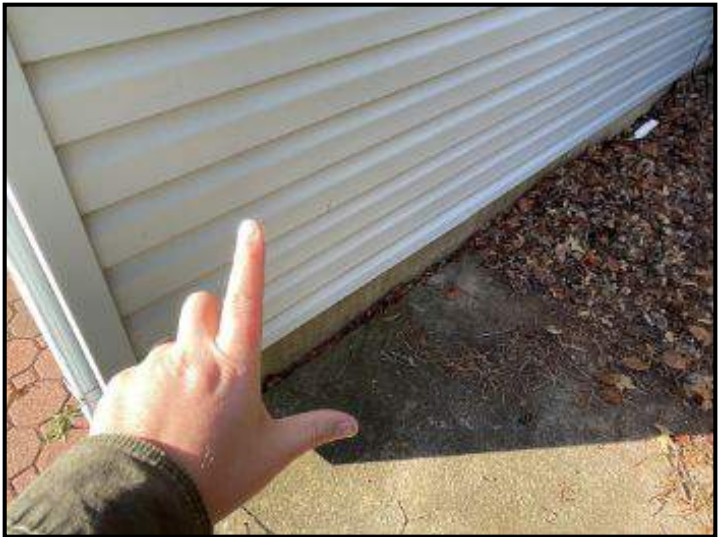
Area of siding not properly secured at side of home

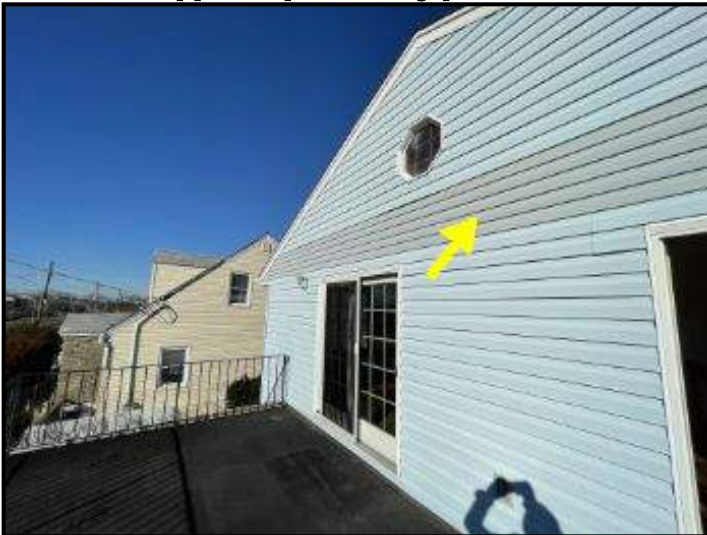
Apparent patched area of siding above upper balcony at side of home

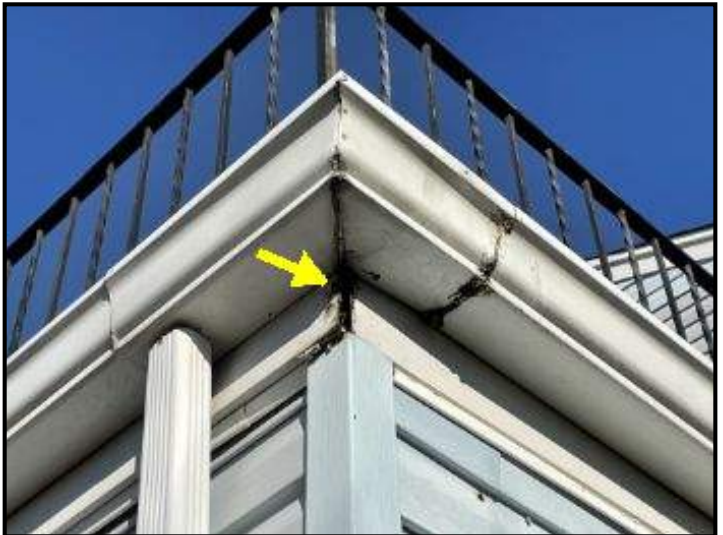
Void at corner of fascia trim at edge of balcony

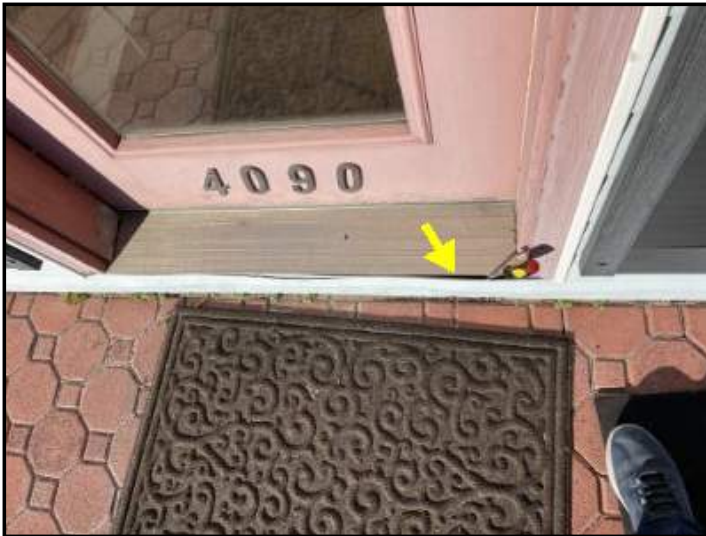
Void at base of front door

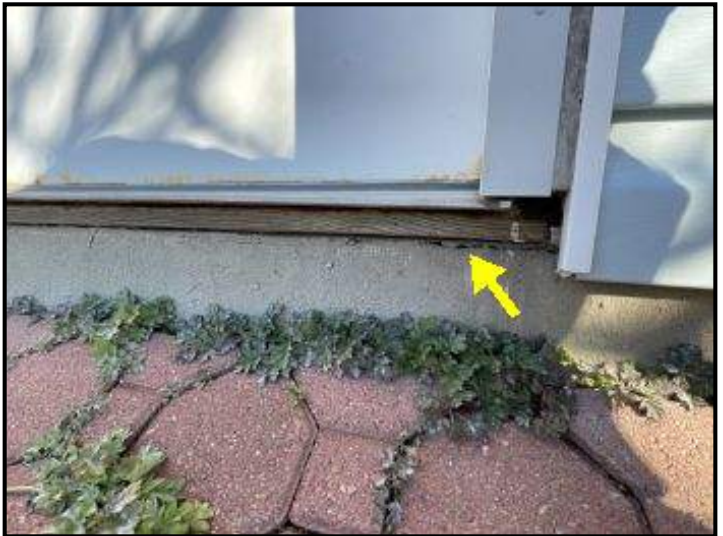
Bare wooden sill at base of side doors

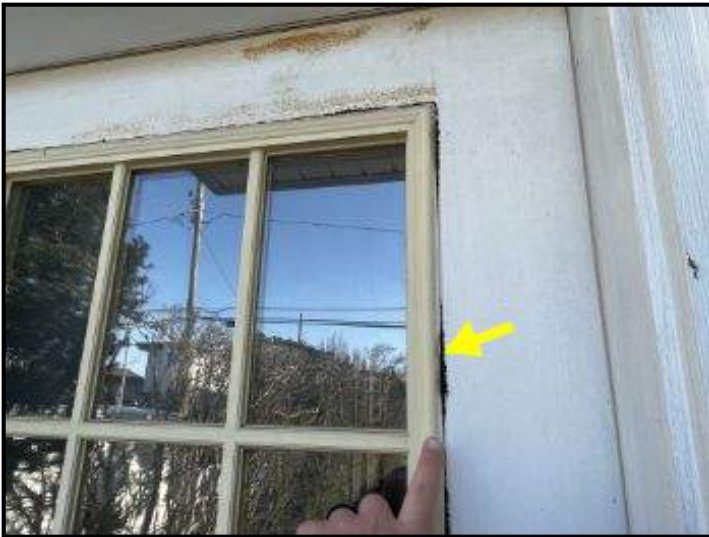
Incomplete caulking around rear door window framing

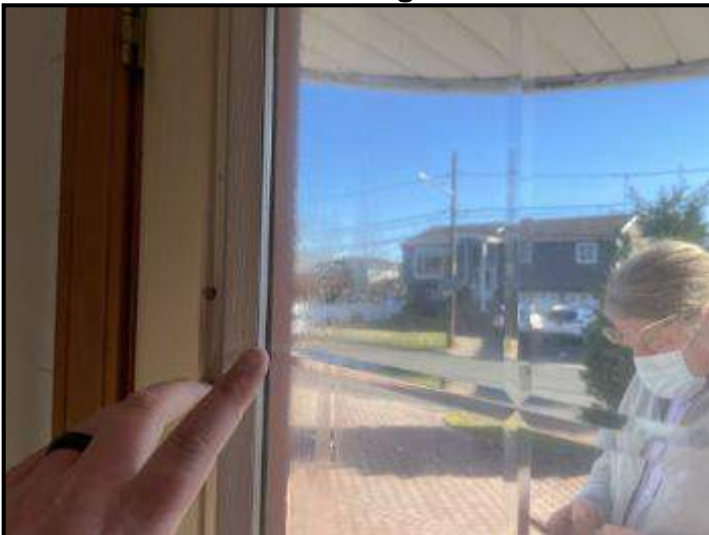
Moisture between panes at front storm door

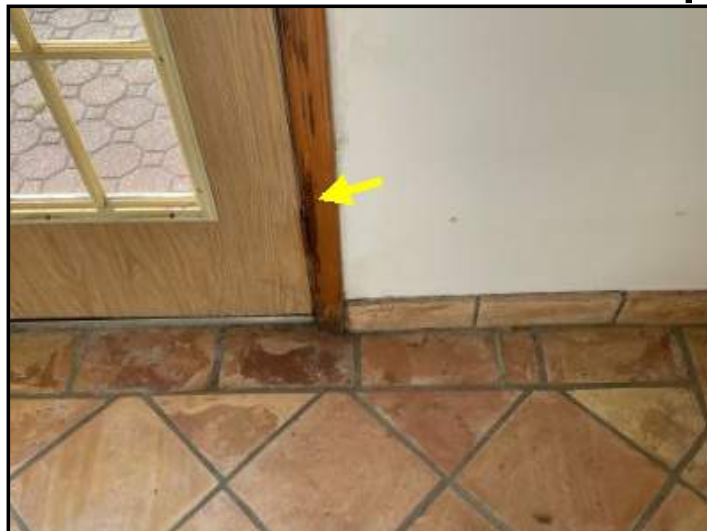
Moisture stains observed around side double door trim at main living room/office

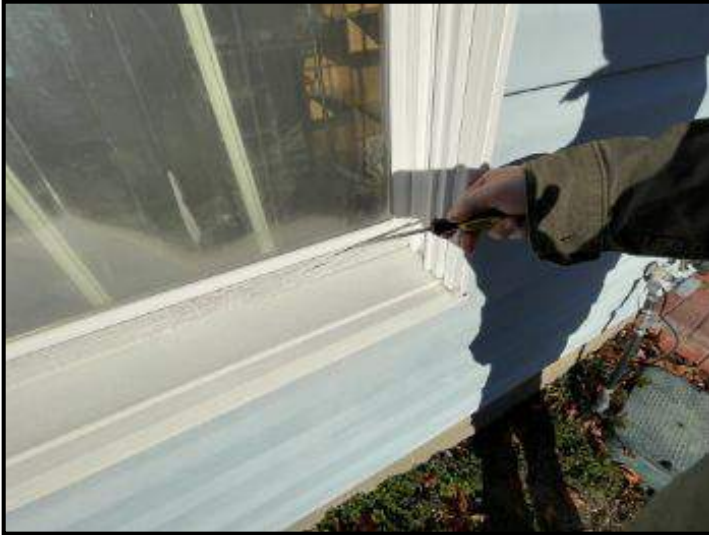
- Overall, the home's windows and frames appeared in serviceable condition.
- **Rotted/deteriorated trim at base of front lower windows; repair warranted.**
- **Moisture between panes at front lower window; repair or replacement warranted.**

Rotted/deteriorated trim at base of front lower windows

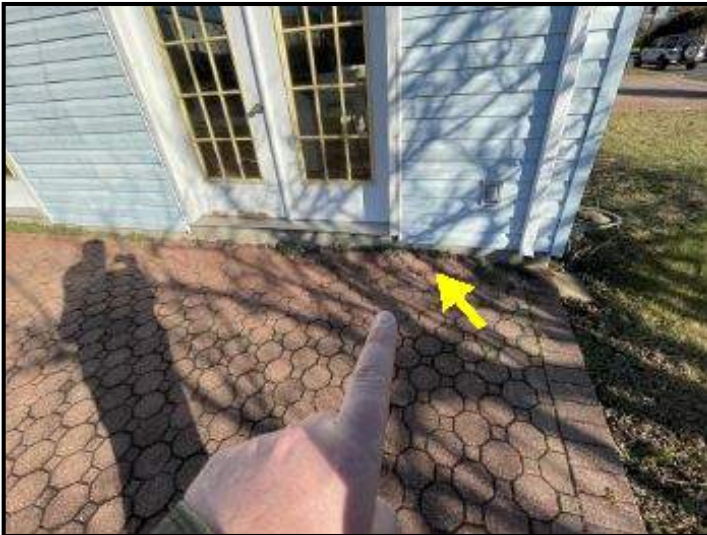
Pavers up-lifted at side paver patio

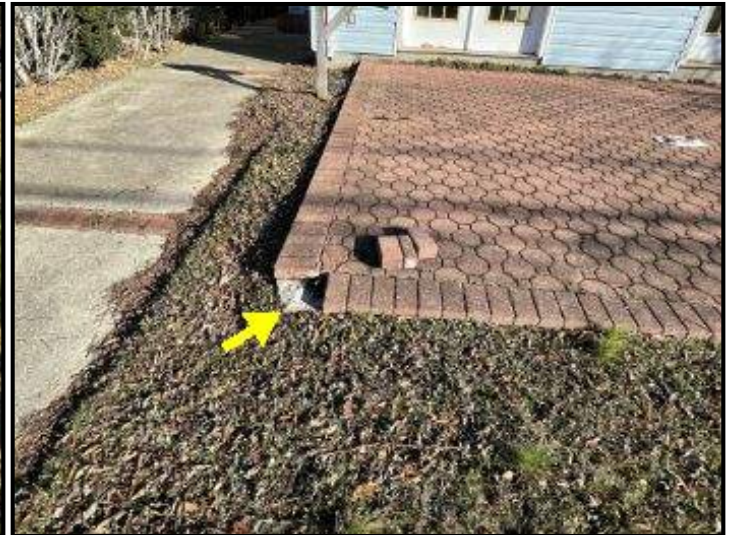
Some pavers at perimeter of side patio were not properly secured

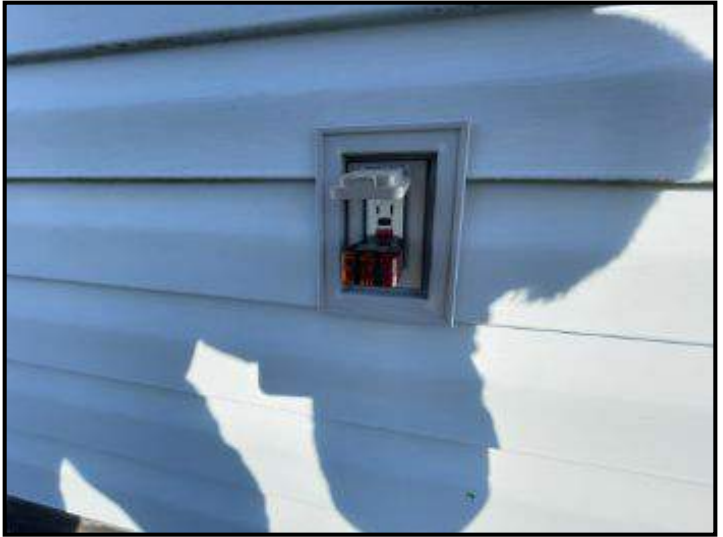
- Some areas of flat roll roofing at upper balcony bubbled/soft; recommend further evaluation by a qualified roofer.
- Non-energized outlet at upper exterior balcony; recommend further evaluation by a qualified electrician.

Non-energized outlet at upper exterior balcony

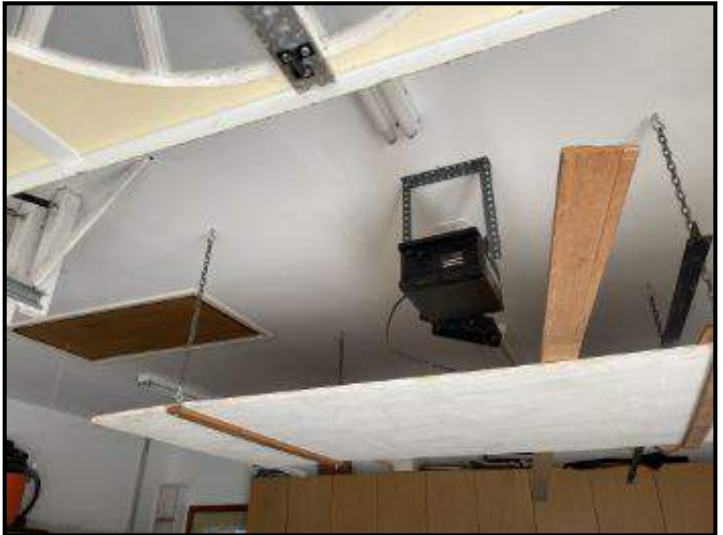
Automatic garage door opener disconnected

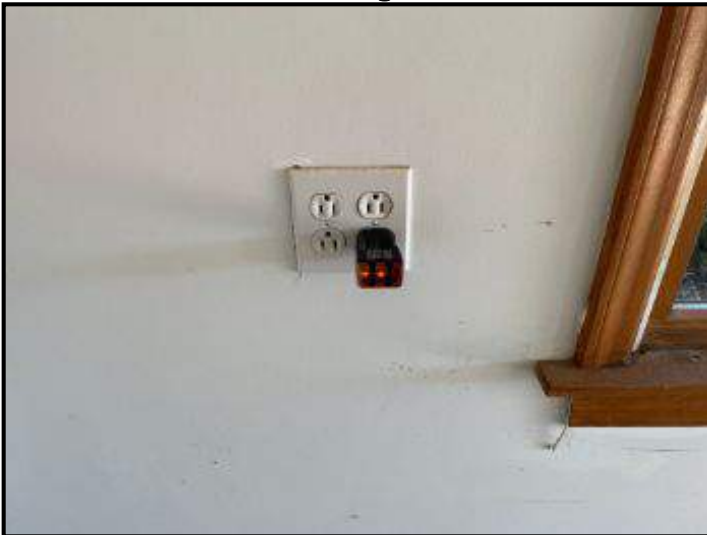
Grounded non-GFCI outlets at garage

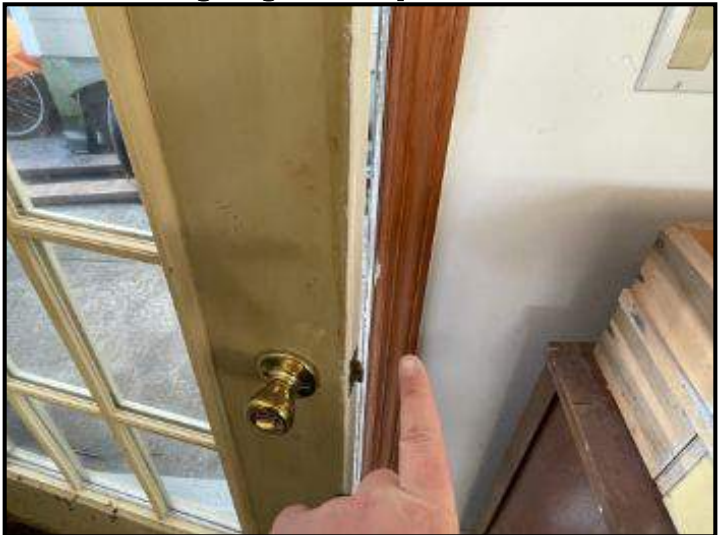
Rear garage door difficult to shut

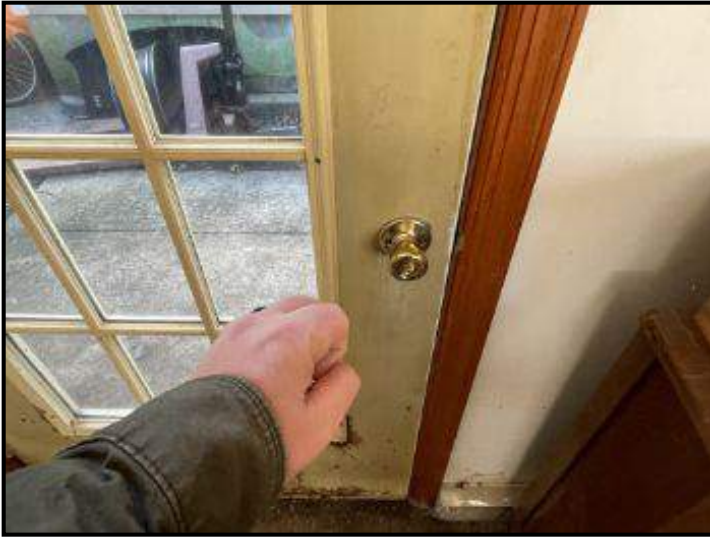
Rear garage door did not lock

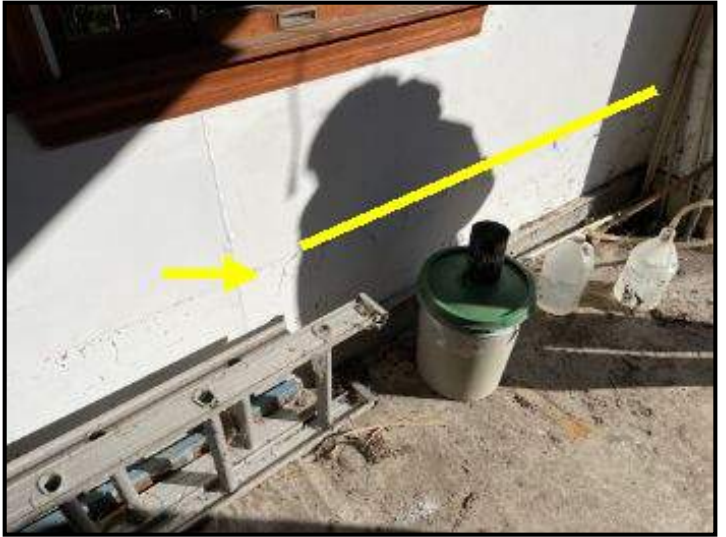
• Water level during Hurricane Sandy visible at garage wall (approx 14" at garage); inspection of potential damage/mold behind walls limited; recommend further evaluation by a qualified contractor/mold specialist. Also, see Overall Home Condition report section.

Water level during Hurricane Sandy (approx 14" at garage)

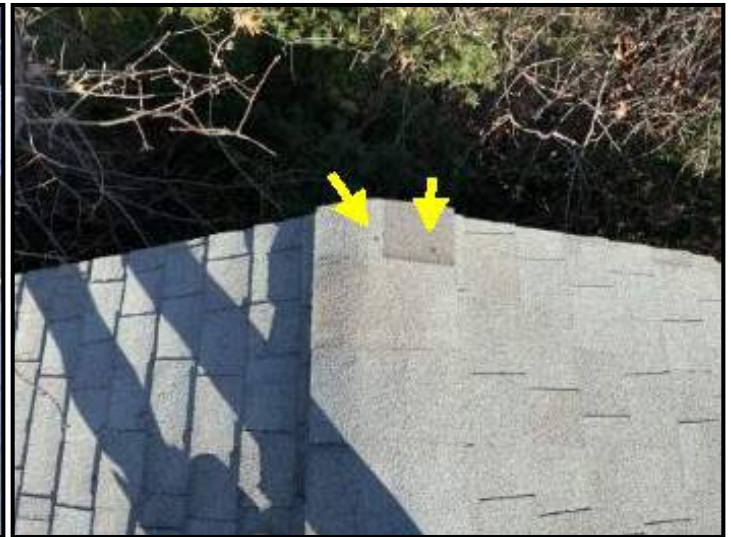
Un-tarred nail heads at edge of roof ridge

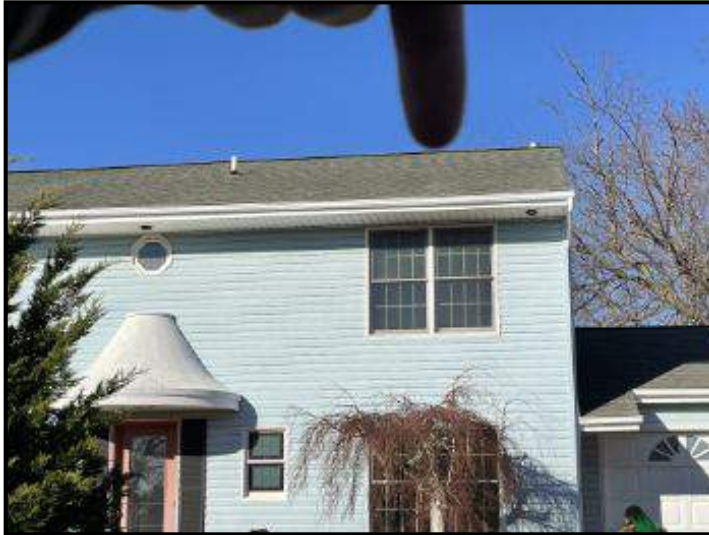
Sag in upper front gutter

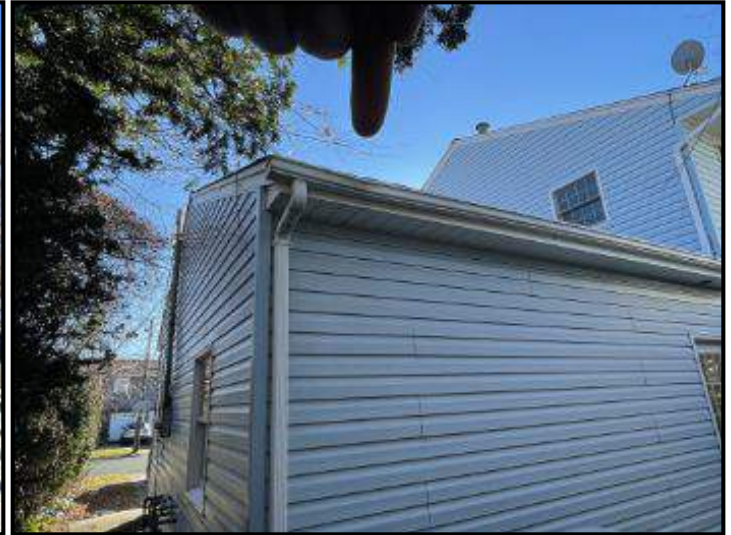
Rear lower gutter sagging

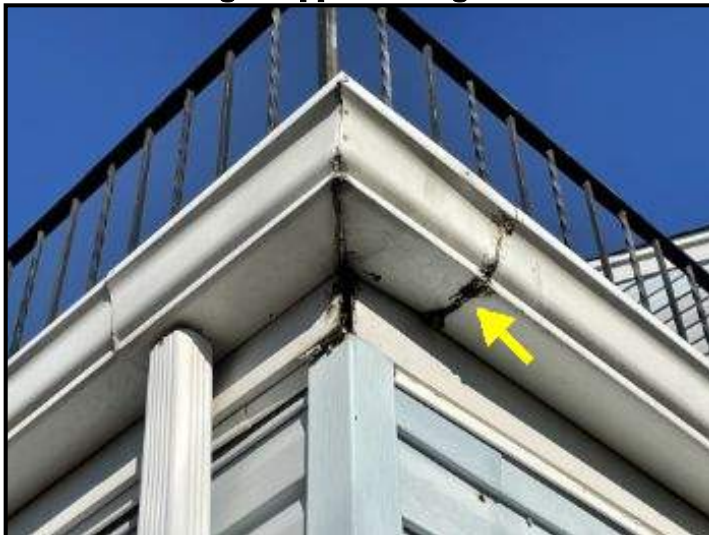
Balcony gutter leaking at gutter seam

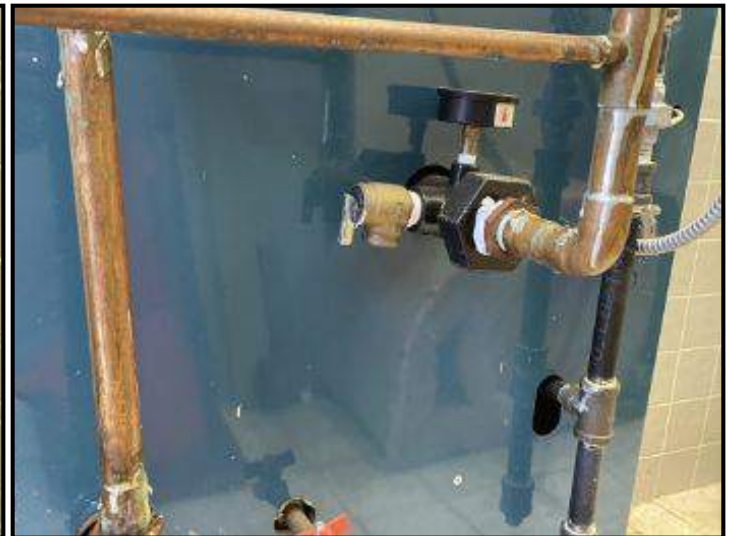
Pressure relief valve not properly installed; no down-line present

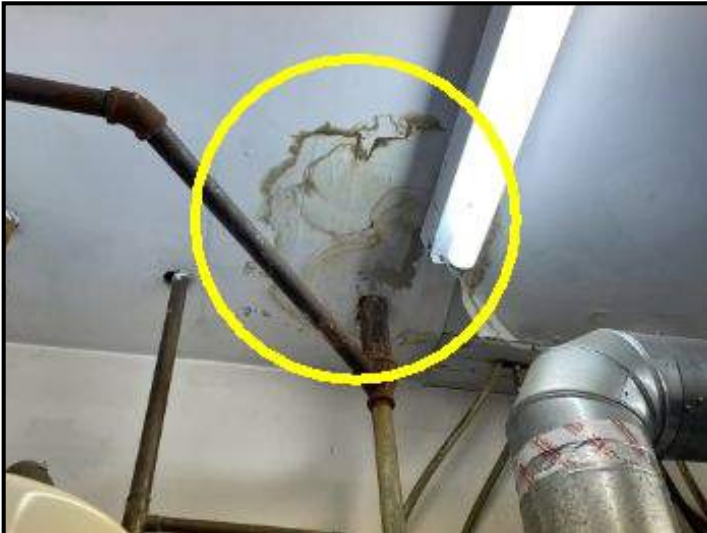
Brown staining around water piping above boiler; no current moisture observed

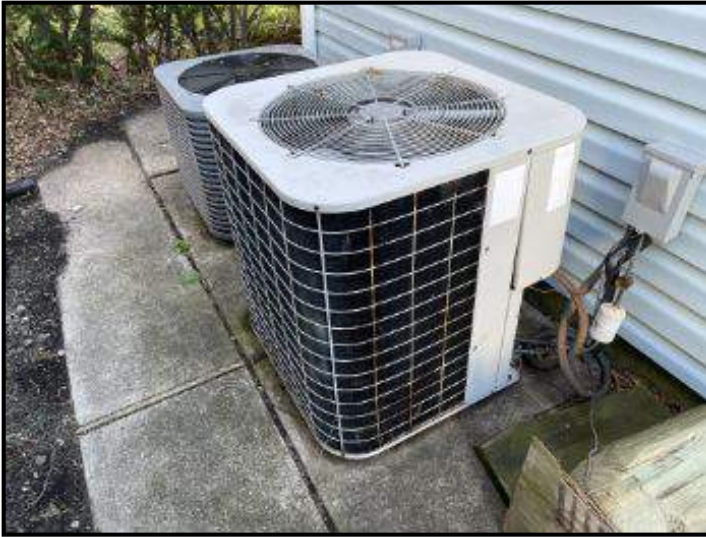
Aged AC condenser

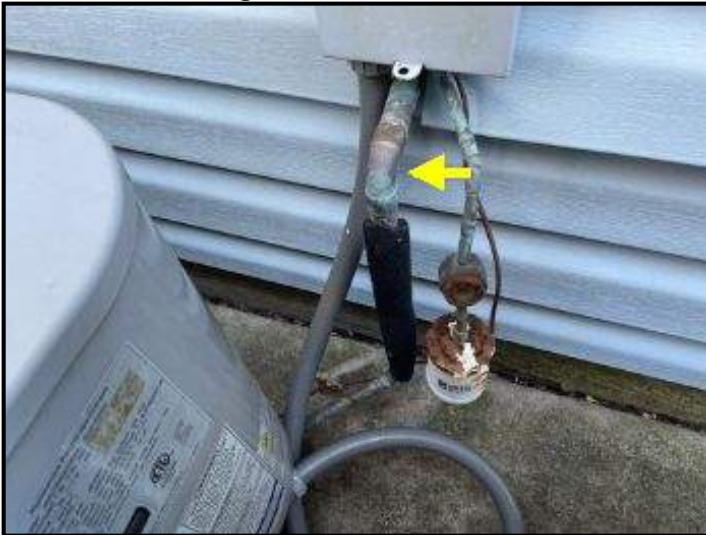
Areas of suction line missing insulation

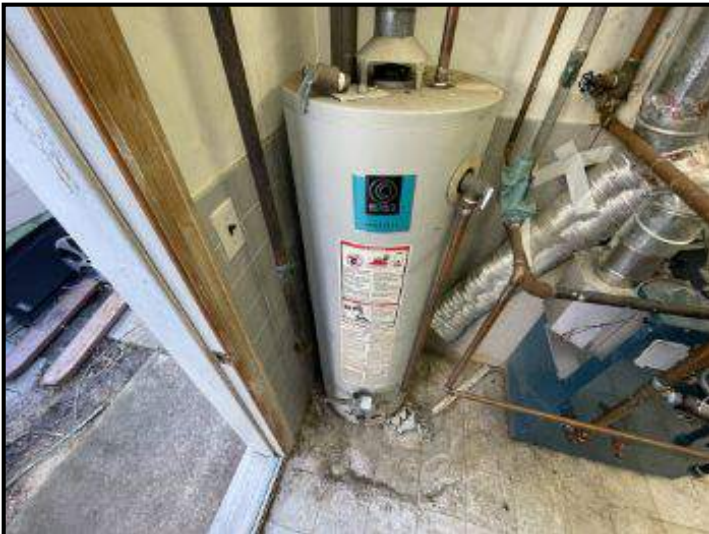
- The water heater's are State gas-fired, 40-gallon unit, manufactured in 1991.
- It is noted that the life expectancy of a water heater is approximately 15 years. Being that the units are 15 years well beyond their life expectancy, recommend to budget for replacement.
- Lower level water heater was not operating at the time of inspection. Hot water was not measured throughout the lower level. Recommend to confirm serviceability and operation, prior to the Closing.

Upper level hot water heater

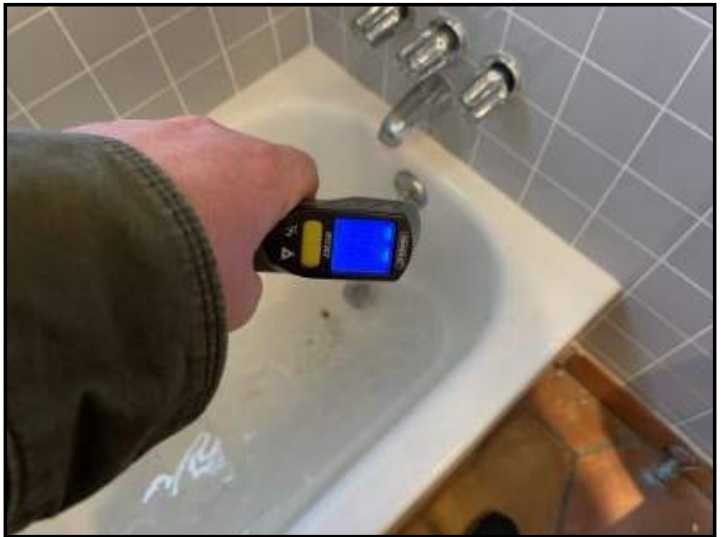
Hot water was not measured at lower main bathroom

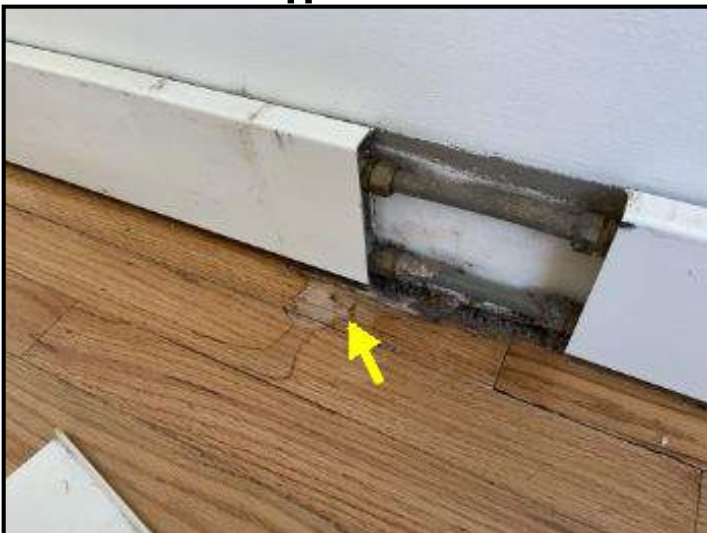
- The home's representative baseboard heaters at the upper level were inspected appeared in serviceable condition with no issues noted. Heat was measured for the representative numbers of the heaters inspected.
- Evidence of past leak at rear upper bedroom baseboard pipe connection; no current leak observed. Recommend to monitor.

Evidence of past leak at rear upper bedroom baseboard pipe connection; no current leak observed

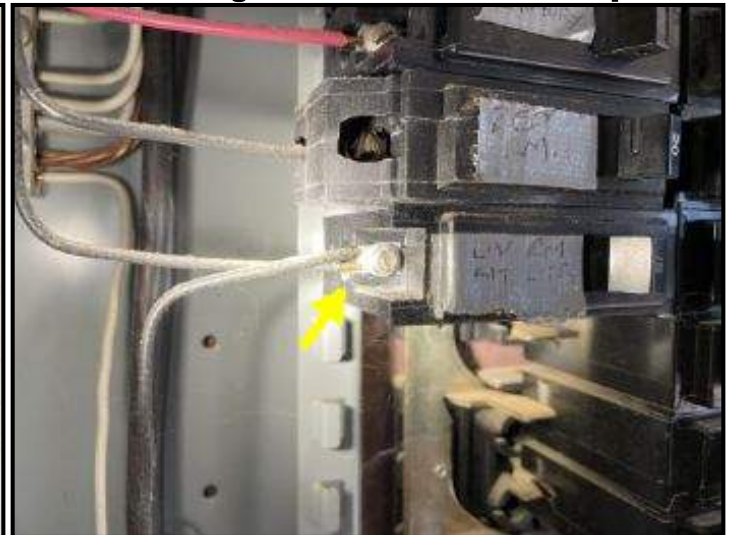
- The main electric panels appeared in serviceable condition.
- Panel cover screw(s) missing and should be replaced.
- **Double tapped breaker inside upper level service panel box (more than one electrical conductor attached). This is not standard practice, and may cause overheating or even an electrical fire. Recommend evaluation by an electrician.**

Double-tapped breaker at upper level service panel

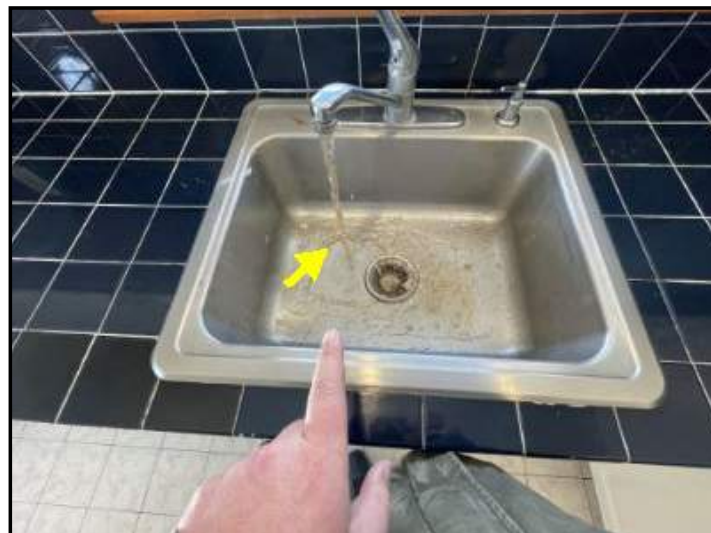
- Supply and discharge lines in serviceable condition with no issues noted.
- Discolored water at kitchen sink, observed.

Discolored water at kitchen sink

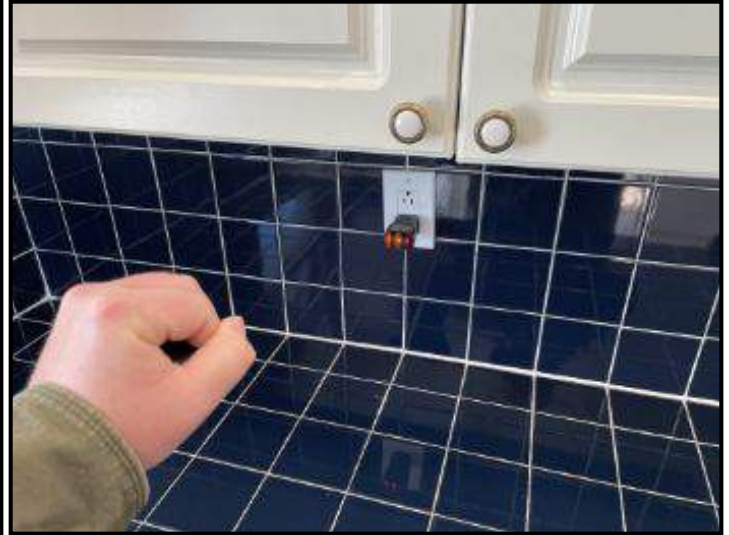
- **Grounded GFCI outlets in serviceable condition.**
- **Grounded non-GFCI outlet at kitchen in series with GFCI outlet; GFCI outlet recommended for safety.**

Grounded non-GFCI outlet at kitchen in series with GFCI outlet

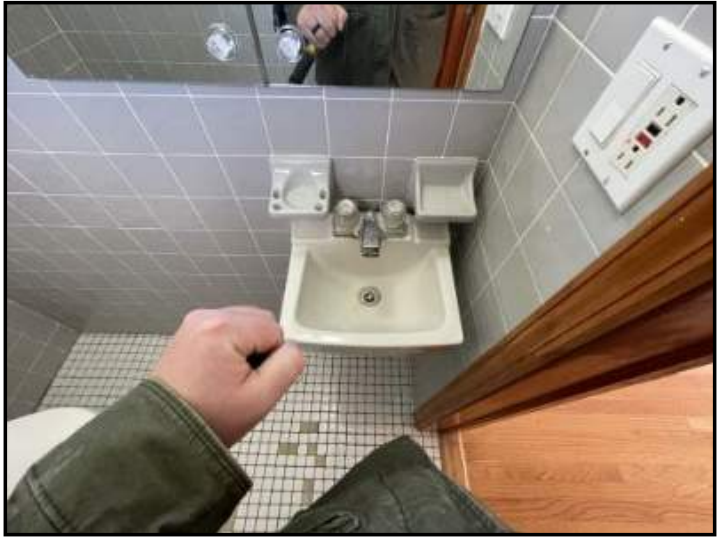
- Some bathroom sinks did not have running water during inspection, noted. See General Home Condition report section.
- Discolored water at upper main bathroom sink, observed.

No running water at upper ensuite bathroom sink/toilet

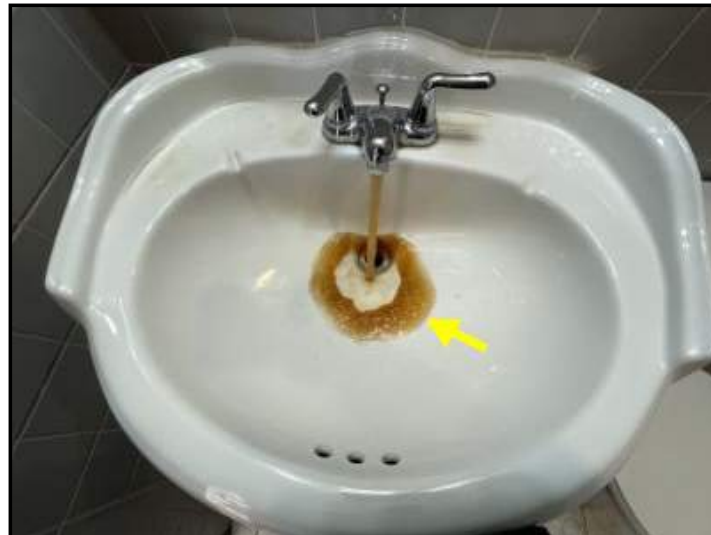
Discolored water at upper main bathroom sink

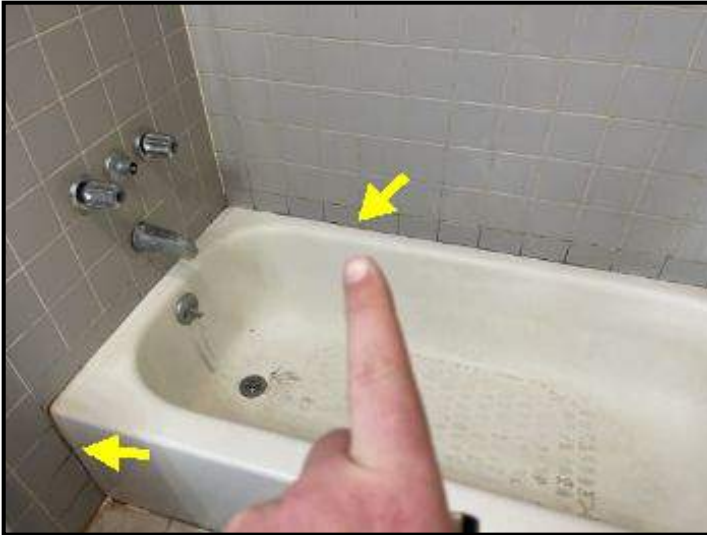
Incomplete caulking around edge and base of tub at upper main bathroom

- Recommended to maintain/recaulk around tubs to prevent potential moisture intrusion below.
- Missing faucet handle at upper main bathroom tub; recommend repair.
- Discolored water at lower main bathroom tub, observed.

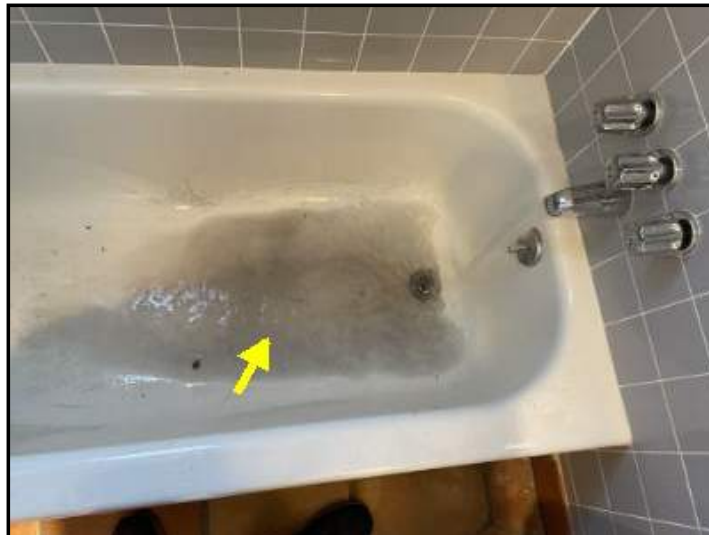
Discolored water at lower main bathroom tub

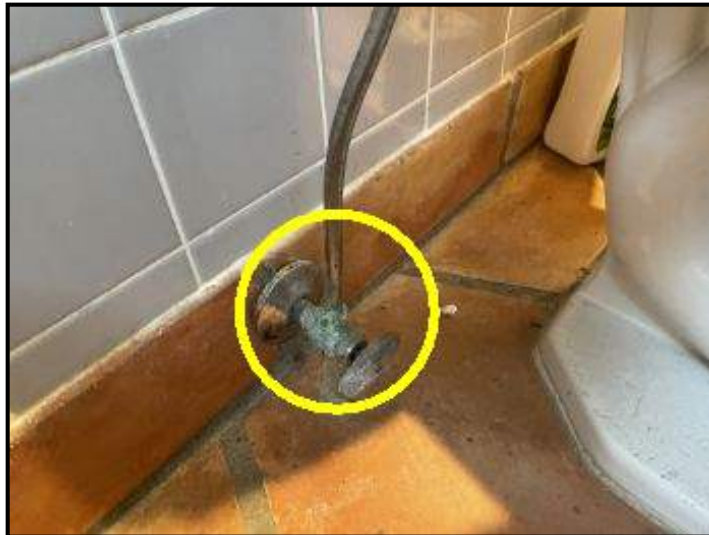
- Some corrosion observed at lower main bathroom toilet supply valve; recommend monitoring.

Some corrosion observed at lower main bathroom toilet supply valve

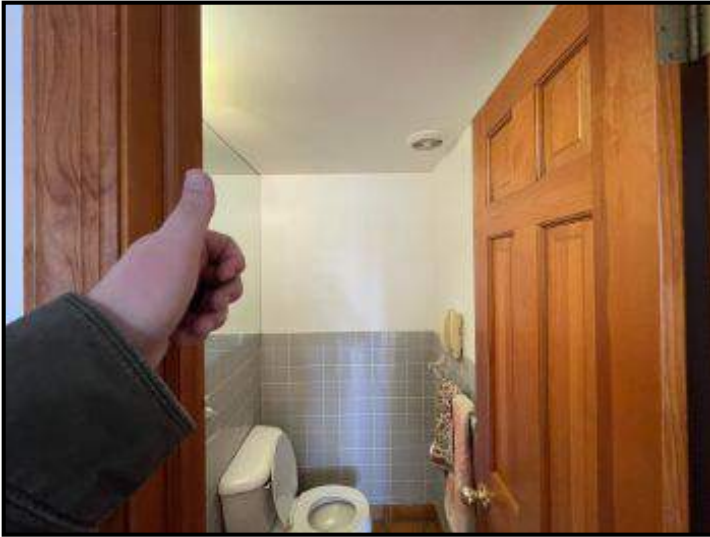
Exhaust fan at lower bathroom operated

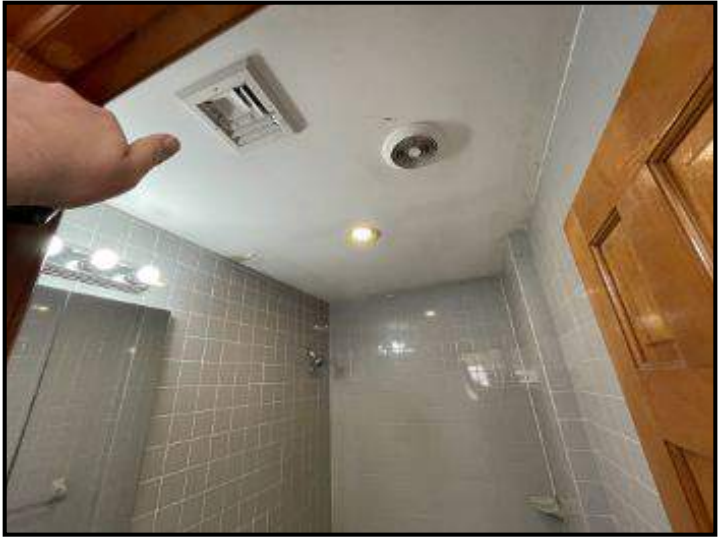
Exhaust fan at upper main bathroom operated

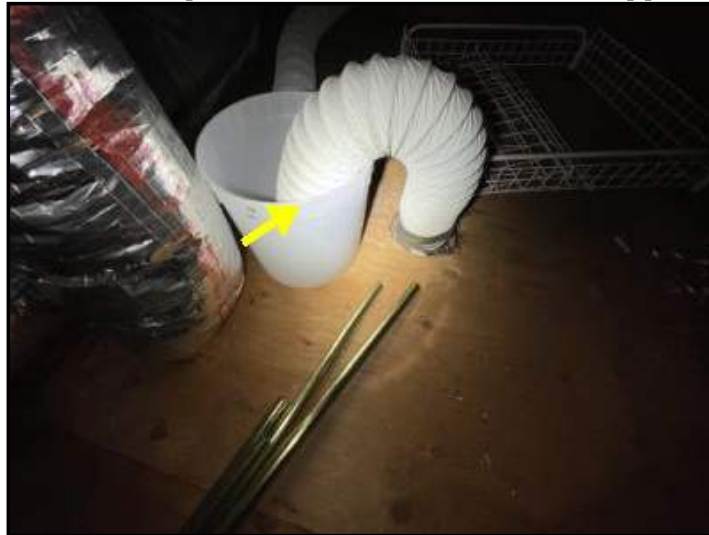
- Main upper bathroom exhaust fan does not discharge to exterior; this can cause condensation within the attic; recommend repair.

Main upper bathroom exhaust fan does not discharge to exterior

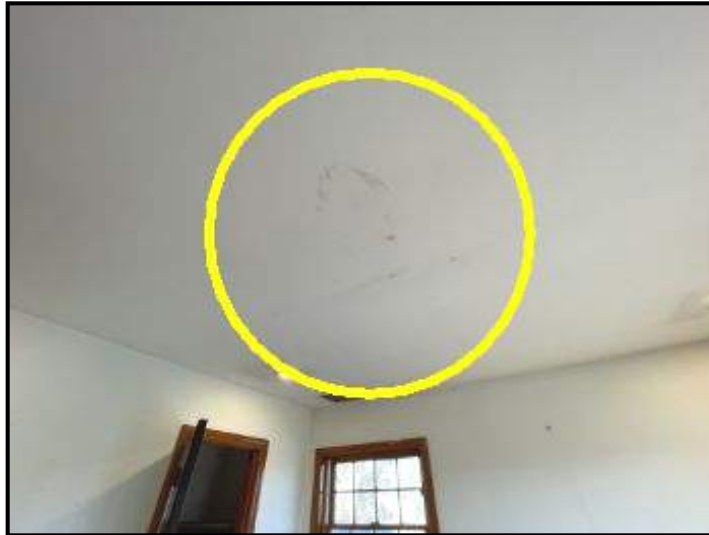
- **Appeared in serviceable condition, no significant issues identified.**
- **Cosmetic marks/bubbled paint at center of upper front bedroom ceiling; no current moisture observed; recommend to monitor.**

Cosmetic marks/bubbled paint at center of upper front bedroom ceiling; no current moisture observed

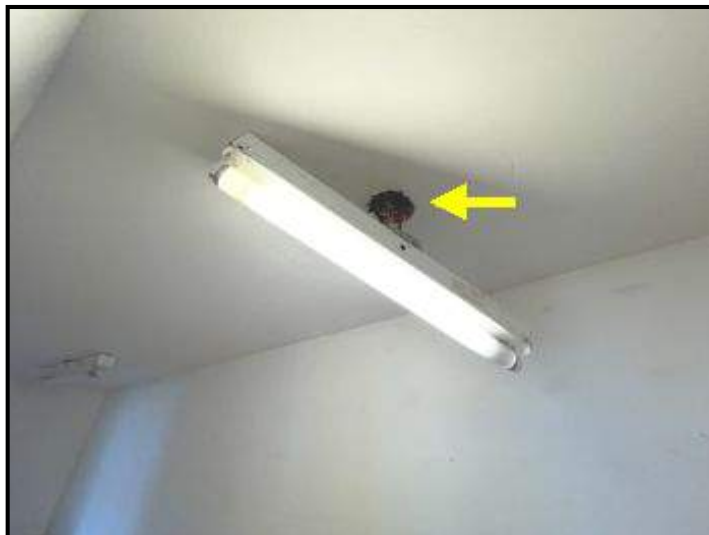
- **Upper front bedroom closet light not properly fastened to ceiling; recommend repair.**

Upper front bedroom closet light not properly fastened to ceiling

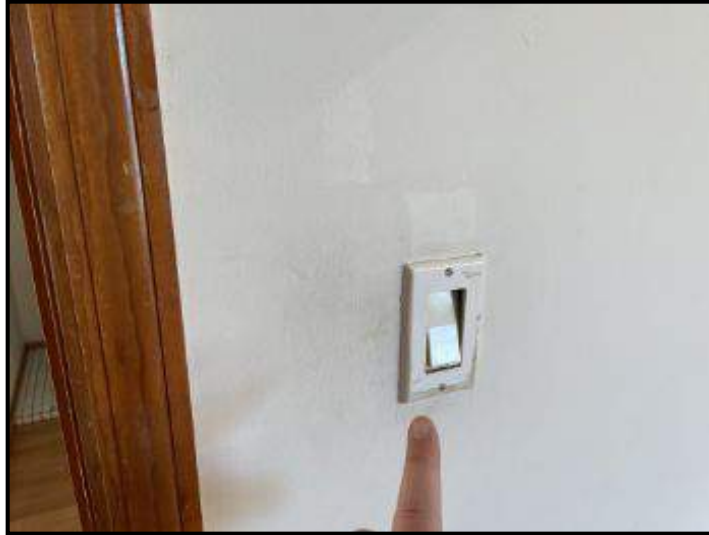
- **Light switch at upper front bedroom recessed; recommend repair.**

Light switch at upper front bedroom recessed

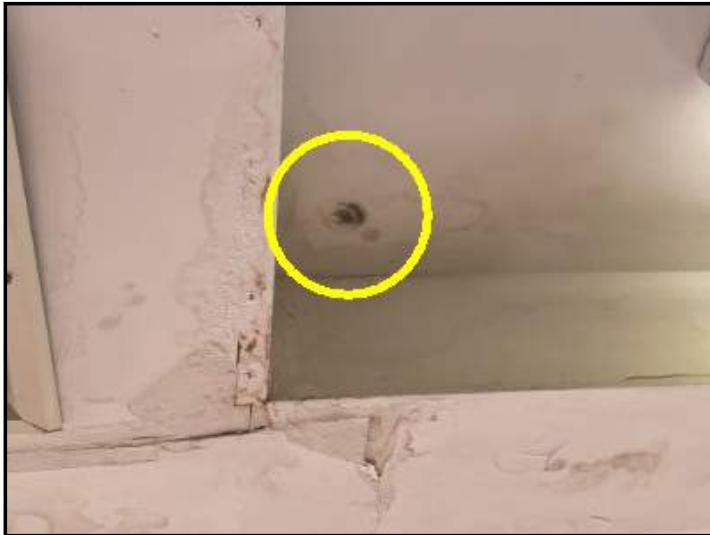
- Possible mold at lower rear office wall and lower living room/office ceiling; recommend further evaluation by a qualified mold specialist. Also, see Overall Home Condition report section.
 - Some staining was observed at areas of tiled flooring at lower level; recommend removal.
 - Several cosmetic cracks/seams at lower and upper living room walls/ceilings; recommend repair.
- Apparent moisture damage at front corner of main living room/office; appears associated to void at exterior fascia trim and leak at gutter-seam. Recommend further evaluation by a qualified contractor. See associated report sections for issues pertaining to moisture damage.

Possible mold at lower main living/office room ceiling near air duct

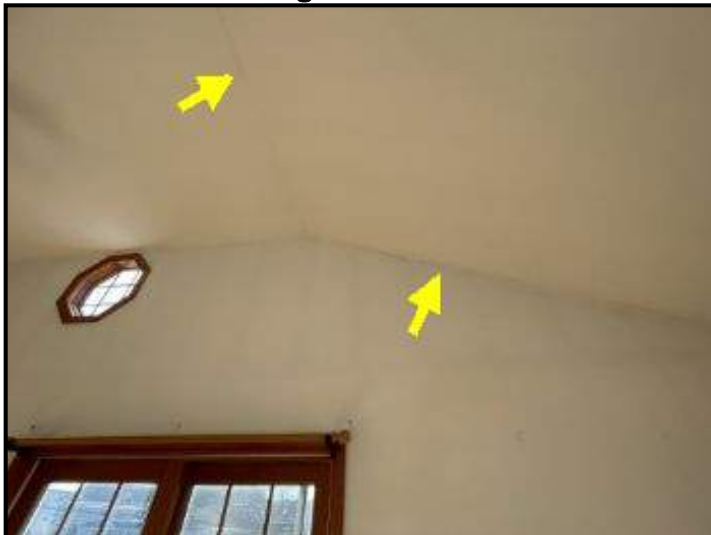
Cosmetic seams at upper living room wall/ceiling joints

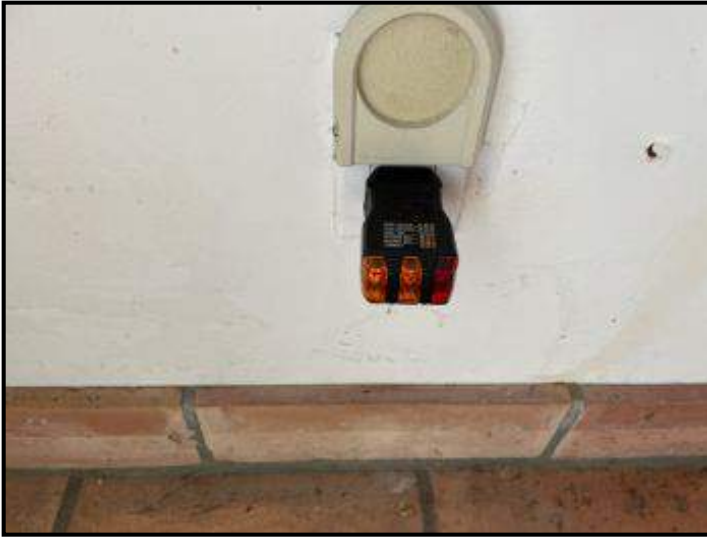
Grounded outlets at lower front den

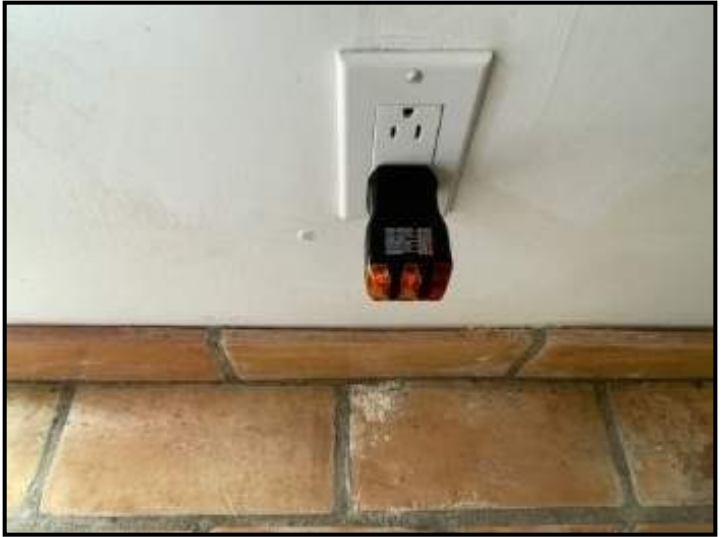
Grounded outlets at main living room/office

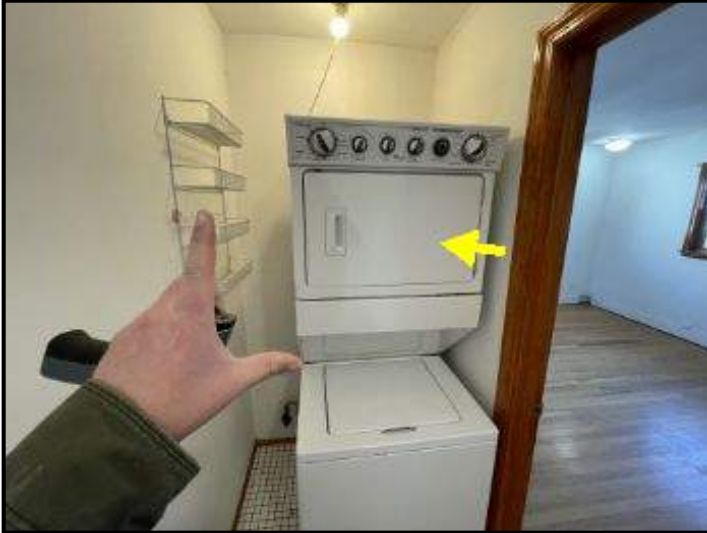
- Washer and dryer, plumbing, outlets, and vent in serviceable condition. Dryer operated loudly, noted. May want to consider updating.
- No pan beneath washer/dryer on second home level for potential leak; recommend installing.

Dryer operated loudly

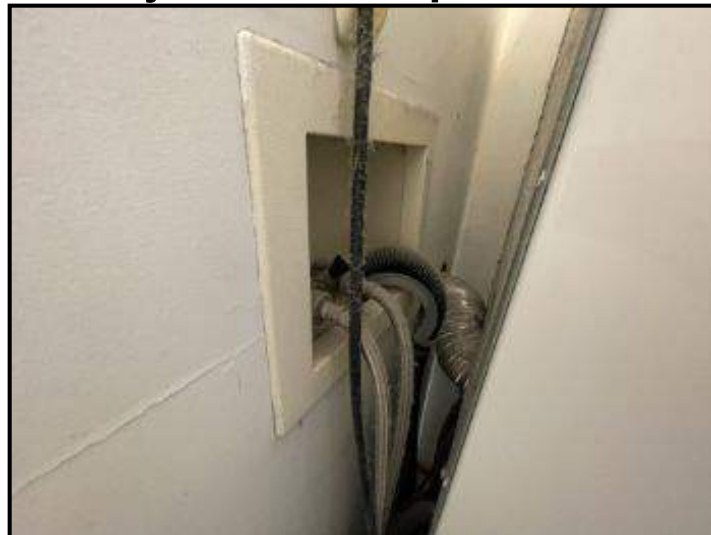
Washer supply/discharge lines

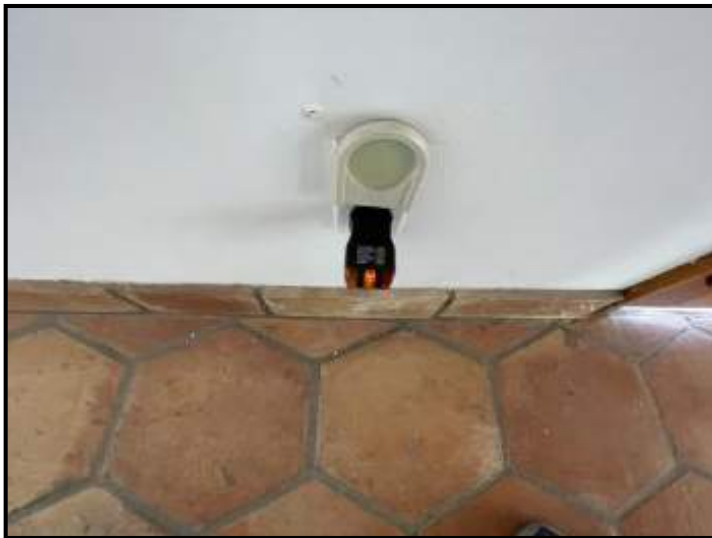
Non-grounded outlet at lower hallway

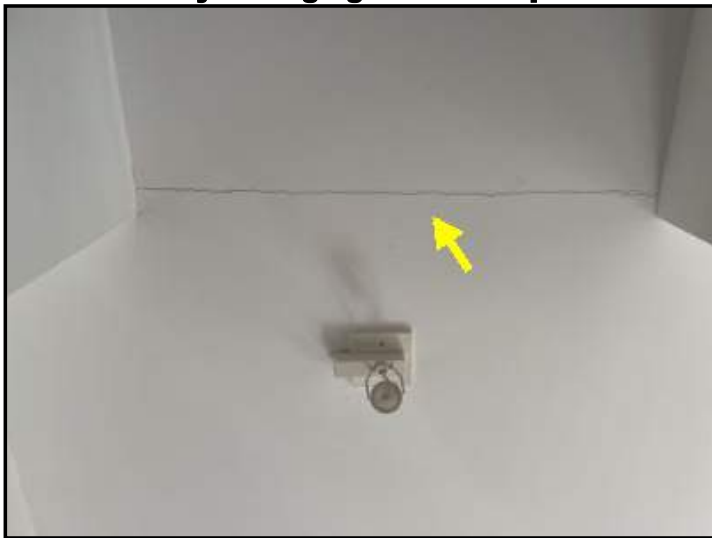
Cosmetic seam at lower hallway ceiling
